Excavations at Melgund Castle, Angus, 1990–96

John Lewis

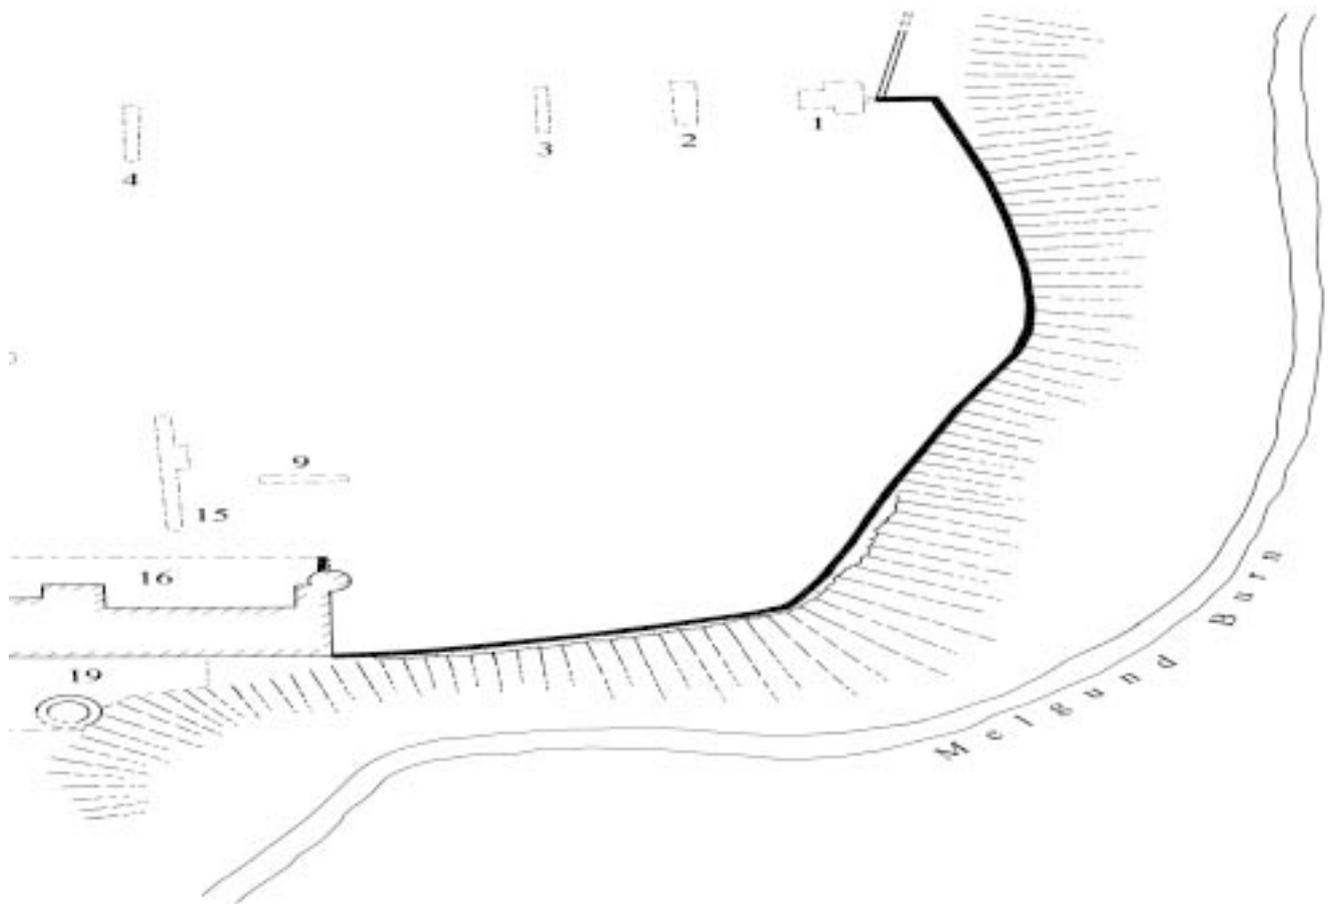
Illus 3 Plan of the castle and its environs, showing the location of the trenches.

The barmkin and the castle's boundaries (Illus 3)

Evidence relating to the enclosures can best be divided into what was retrieved from three separate areas: Trench 16, to the immediate N of the castle, where remnants of the barmkin were uncovered; the N side of the field where some evidence of an outer boundary was uncovered; and the area to the W and SW of the castle where post-Improvement field walls overlay the foundations of other walls that were probably contemporary with the castle.

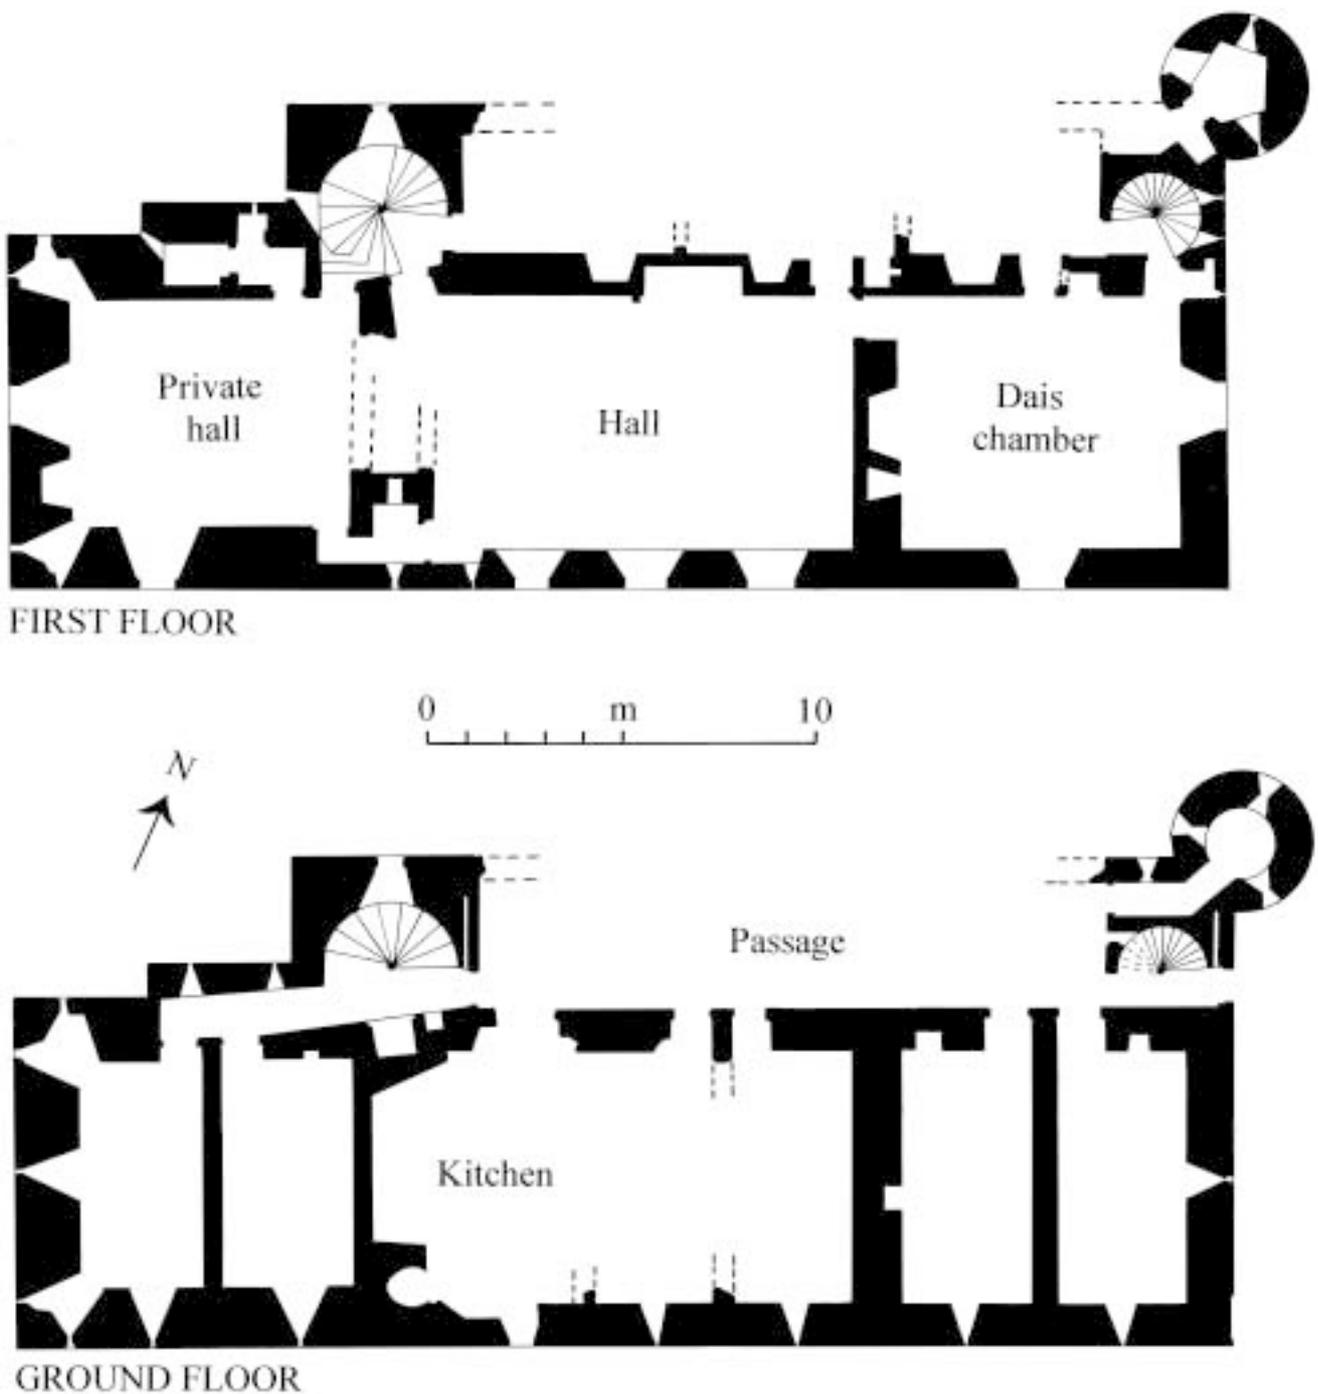
Illus 4 Ground-floor and first-floor plans of the castle.

Historical and architectural summary (Illus 4)

The tower house (Illus 4–6)

The east range (Illus 4–6)

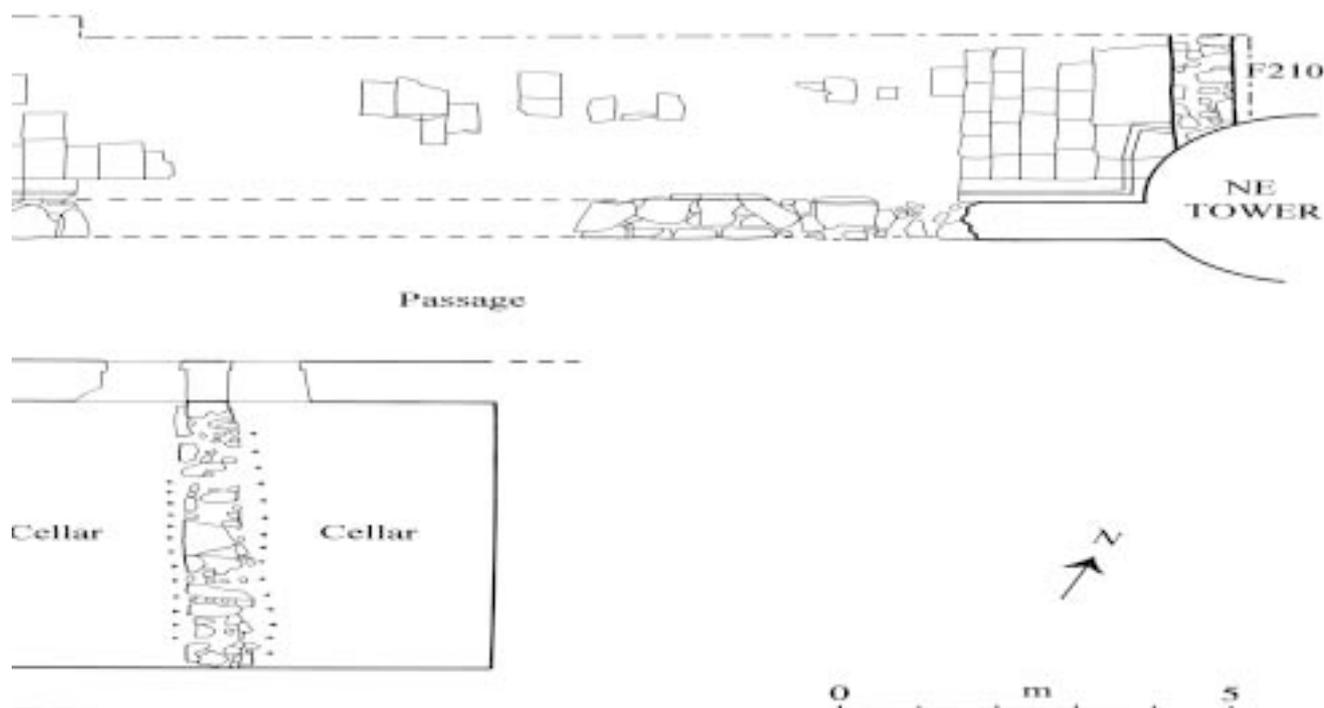
Illus 5 Plan of the north side of the castle, showing the excavated remains of the vestibule, and the east and west walls of the barmkin with its paved floor.

The north side of the castle (Illus 5, 7 and 8)

more secure by the addition of a small vestibule against the original doorway. The vestibule measured only 1.8m by 1.4m; of its 0.6 m-wide mortar-bonded rubble walls, only one course survived. Because it had been demolished to ground level and there was no obvious threshold, it was not clear from which direction the vestibule had been entered although the wear on the flagstones to its N suggests entry might have been from that direction.

The floor of the vestibule was flagged. Similar paving extended around its exterior, forming what was probably the surface of a courtyard, which appeared to be contemporary with the addition. Only remnants of this flagged surface survived, its best preserved sections being adjacent to the vestibule and in the angle between the NE tower and wall F210, which ran northwards from it (see below). A channel, 10mm wide and 4–7mm deep, had been cut into the flags, presumably to remove rainwater from the courtyard. The channel sloped gently downwards towards the E as far as wall F210, which appeared to have truncated it. Excavation did not extend E of wall F210 and the full course of the drainage channel remains unknown.

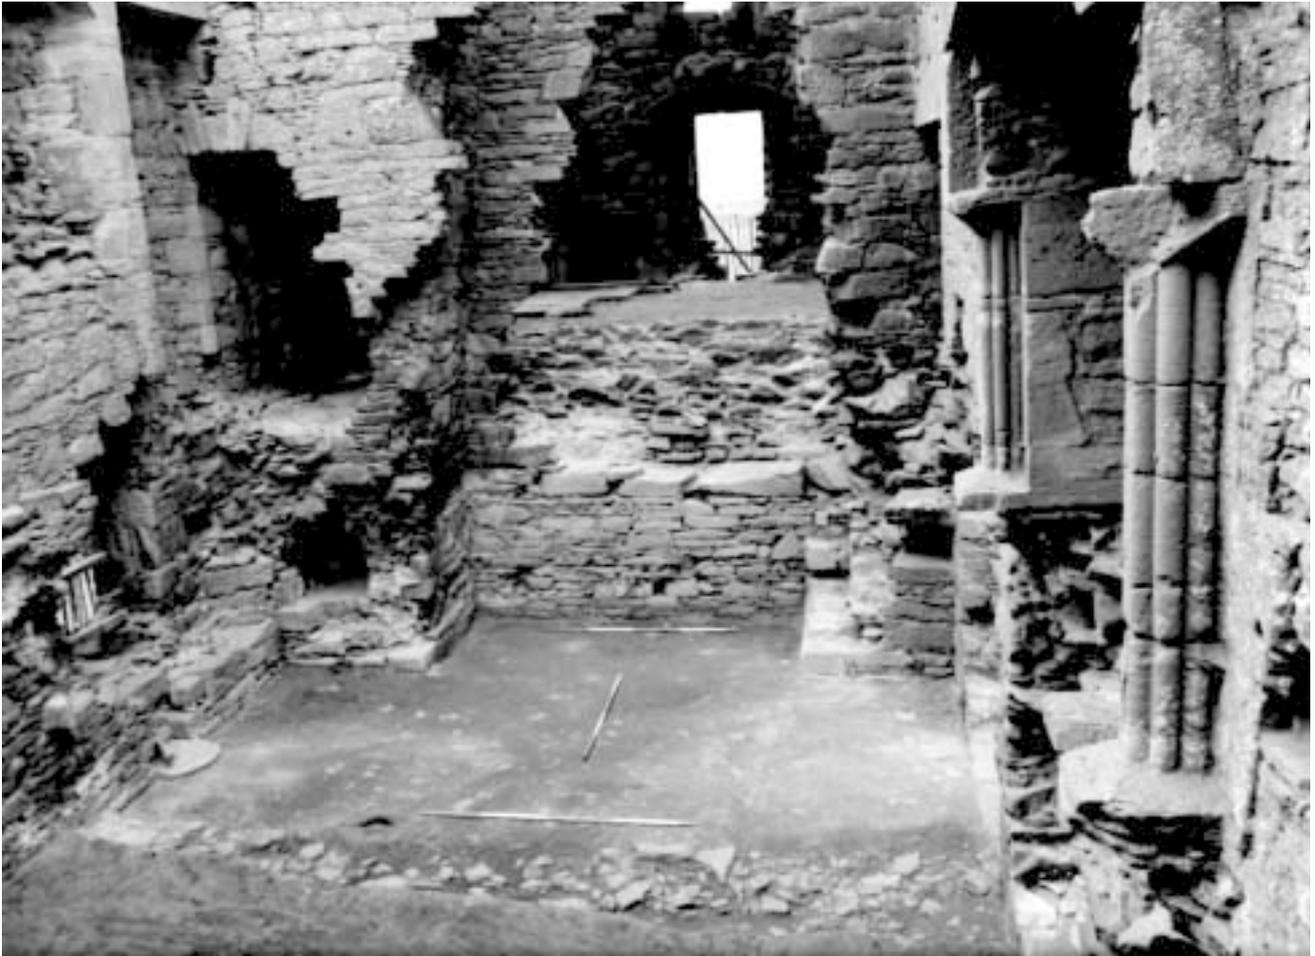
Illus 6 View from the east into the first-floor hall of the tower house, with the ground-level kitchen in the foreground. Note the oven on the south side of the kitchen fireplace.

The most striking feature of this, the westernmost of the three chambers below the hall, was its massive fireplace which was 3.7m wide and recessed some 1.8m

into the room's W wall. Its chimney was almost entirely demolished below first-floor level where its surviving remains were in a very dangerous condition. In the right-hand side of the fireplace, in its uppermost surviving course of masonry, about 1m above floor level, was a narrow check for a salt box, only the back and W side of which survived.

Set into the W wall, to the left of the fireplace and 0.6m above floor level, was a circular oven, 1m in diameter, whose front was missing. Its domed roof was built of squared blocks of sandstone which had been damaged by heat whereas its floor of similar masonry was remarkably well-preserved. The flue from the oven connected with the main chimney of the fireplace.

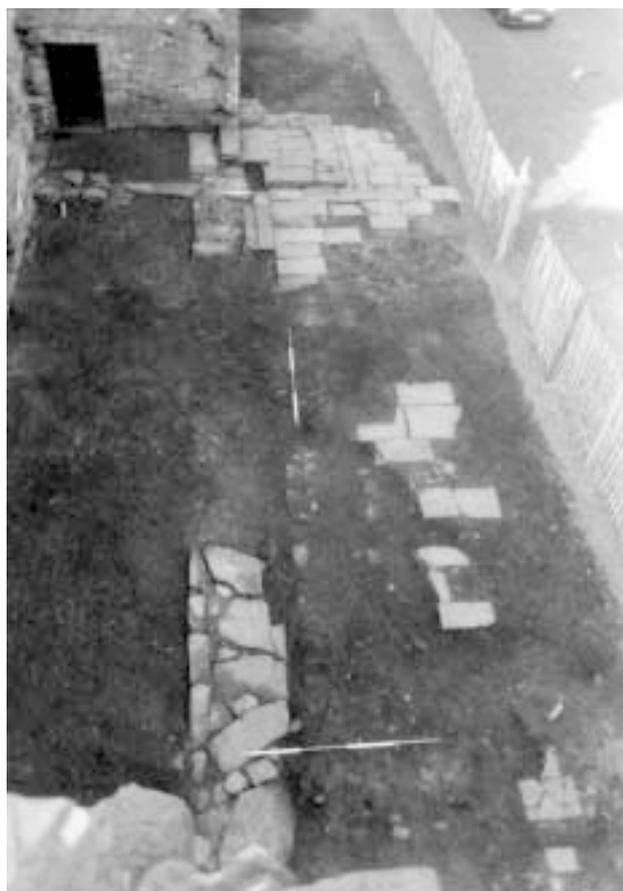
Illus 7 The north side of the castle, showing the excavated remains of the north wall of the passage, the vestibule and the paved floor of the barmkin. Viewed from the east.

The masonry of the N wall of the passage was integral with that of the stair tower and the NE tower and appeared to be an original feature of the castle. The entrance into the castle had been at the W end of the passage, through a 1.2 m-wide doorway, whose right-hand jamb was set into the E wall of the stair tower. At some stage, the castle entrance appears to have been made

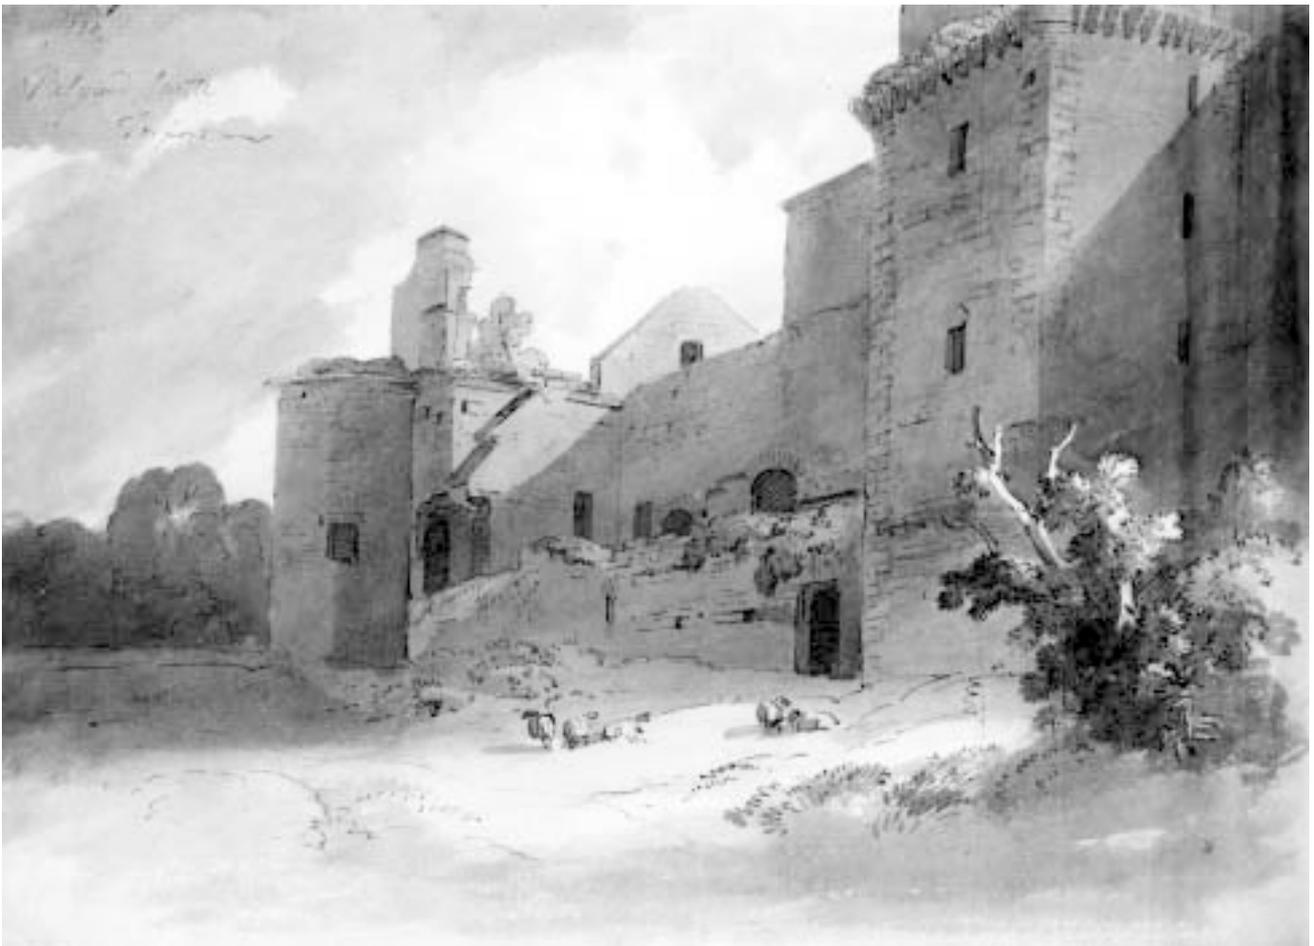
Illus 8 Pen and ink drawing by Hugh 'Grecian' Williams, dated 1802, showing the north wall of the passage still standing.

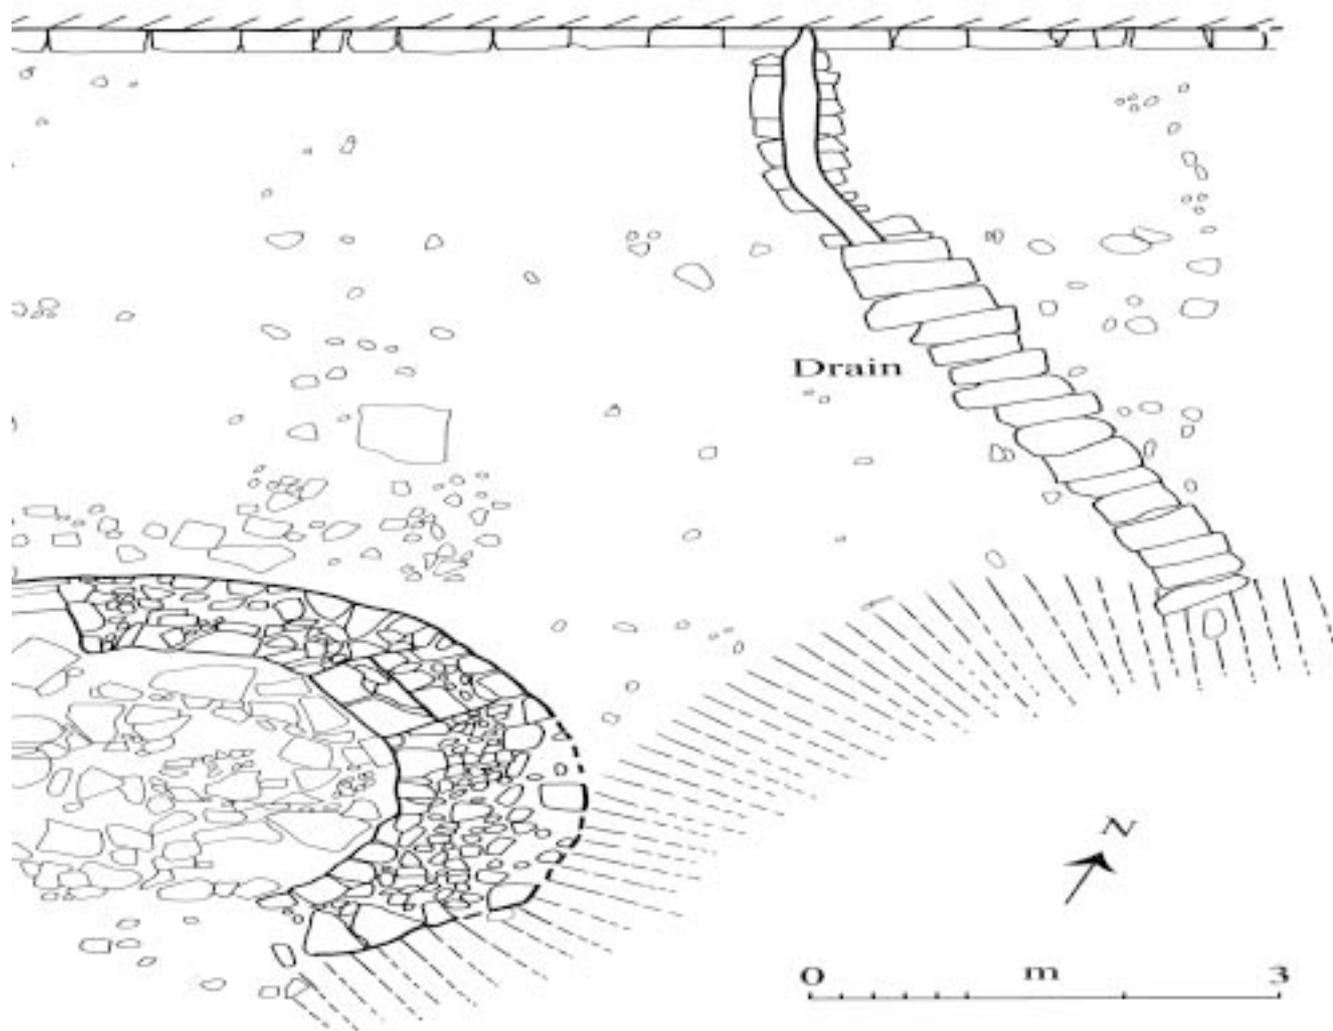
Illus 9 Plan of the south terrace, showing structure F308, walls F313 and F319, and the drain.

Running southwards from the tower house, at an angle of 10° to wall F313, were the fragmentary remains of wall F319, which survived as a single course of masonry for a length of about 8m. This wall was 1m wide and

built of sandstone rubble bonded with yellow clay, identical to that used in wall F202 on the N side of the tower. Destruction debris overlay wall F319 and extended a short distance to the S of it. Although it is not clear how this wall related to other structures nearby, it might have been a precursor of wall F313; another possibility is that it was associated with circular structure F308 to which it might once have been joined (see below).

Running southwards from the sink outflow in the E range kitchen was a drain which extended across the terrace as far as the break of slope above the Melgund Burn. Built of unworked sandstone rubble, its 0.2m-wide channel was capped with crude sandstone flags although these were missing from the northernmost 2m of its length. The drain was not floored and its fill consisted entirely of topsoil containing 19th-century pottery. This suggests that the missing capstones had been removed fairly recently.

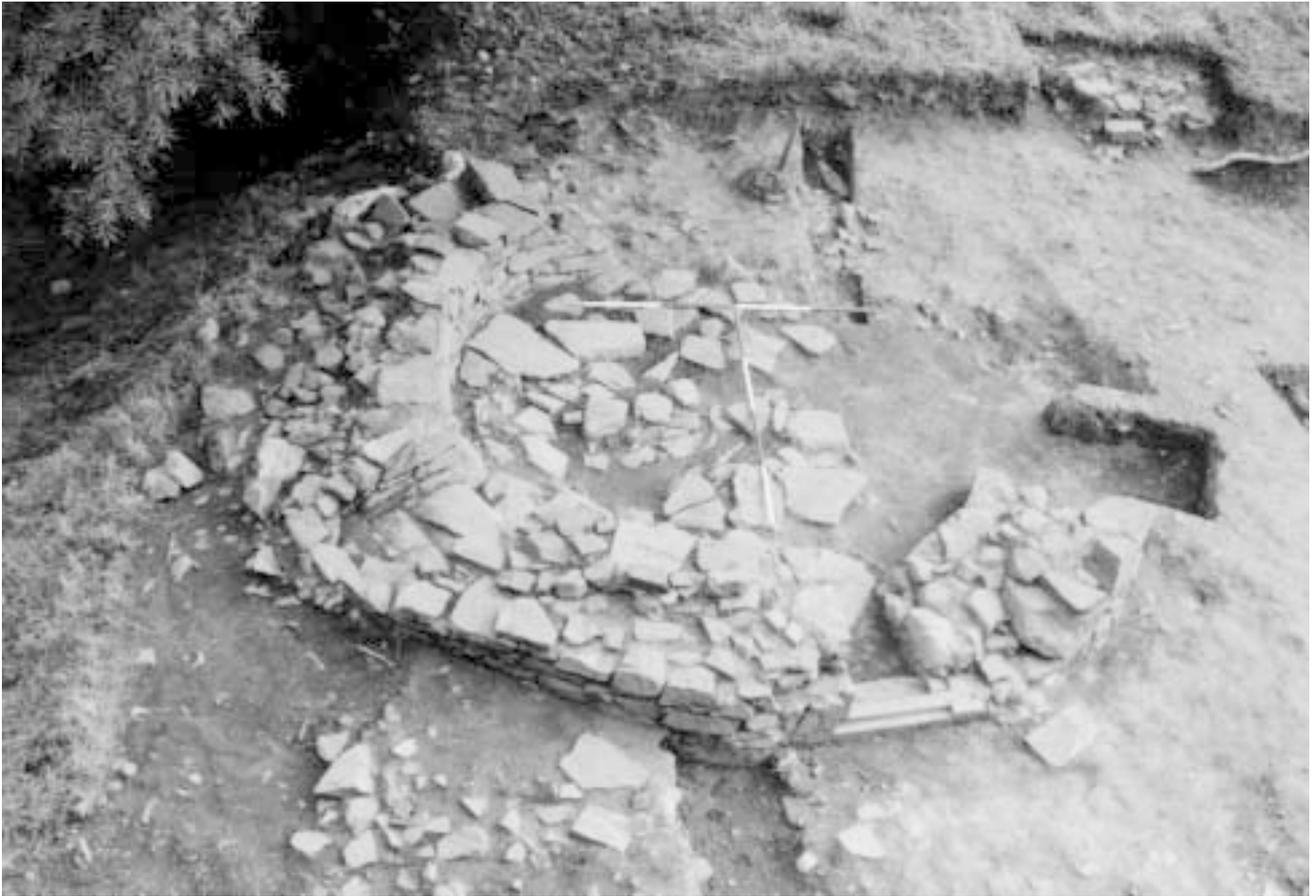
Illus 10 View from the north of structure F308. Note the doorway on its north side.

within walls 1m thick which increased to 1.4m on the SE, presumably to provide additional support near the edge of the slope. The building had been completely demolished on its S and SW sides although its bedding trench was still visible in places. Its masonry comprised coursed sandstone rubble bonded with pink, clayey silt, which stood to a maximum height of 0.8m on the N side of the building. Its interior was floored with crude, but reasonably flat, sandstone flags, which had been badly disturbed by tree roots and animal burrowing. There was no obvious sign of wear on these stones and no deposits overlying them that might have helped interpret the building's function.

On the N side of the building was a doorway, only 0.55m wide, with an E jamb of neatly-cut sandstone blocks of which two courses survived. An iron hinge for a door was set into the outer face of that jamb, a complementary check in its masonry indicating that the door had opened outwards; the 120° angle of the check would have allowed the door to open wide. The W jamb

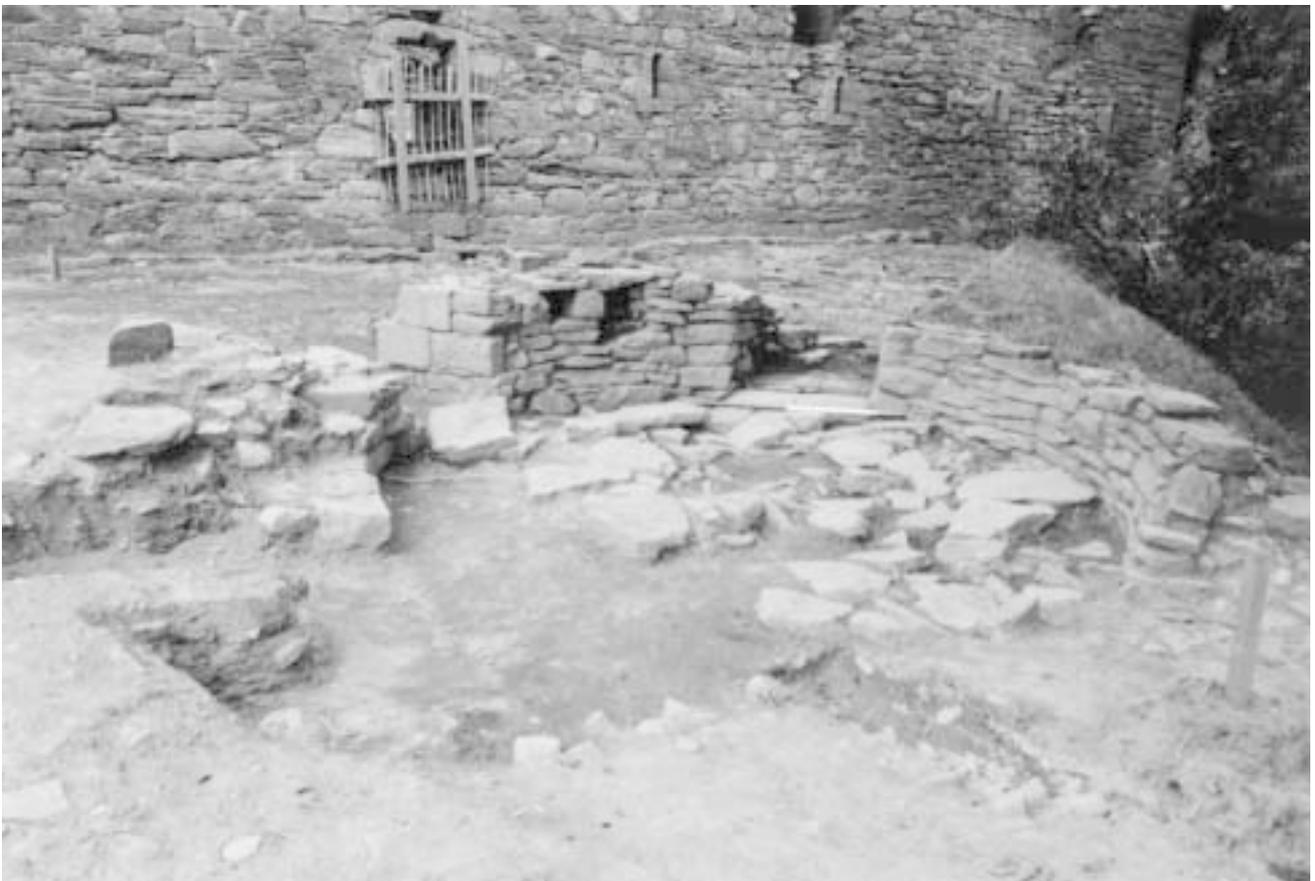
Illus 11 View northwards from the interior of structure F308, showing the doorway and, to its east, the recess with its blocking removed.

was much cruder; it may have been a secondary insertion although this could not be confirmed. One of the carved stones from the W jamb was recovered from the collapsed masonry within the doorway. Sunk into its outer face was a small socket with traces of lead and iron-staining, derived from an iron clasp or hinge, although at what height the stone had been set is not known.
