Investigations into an early timber-frame roof in Brechin, Angus

Anne Crone, Neil Grieve, Kevin Moore and David Perry

The building at 68-74 High St, Brechin retains an intact timber-framed roof which was constructed sometime before 1717. Dendrochronological analysis of the oak timbers and subsequent study of the redundant joints visible on many of the timbers revealed that an earlier roof, House 1 dated to 1470 AD, had been dismantled and some of the timbers re-used in the present roof, House 2. The timber used in House 1 had been imported from Scandinavia and the roof was probably tiled. Documentary sources were examined to elucidate the history of the building. House 1 may be the 'slate house' mentioned in the late 15th century. There was a property on the site in the early 17th century but without dendrochronological dates House 2 remains undated.

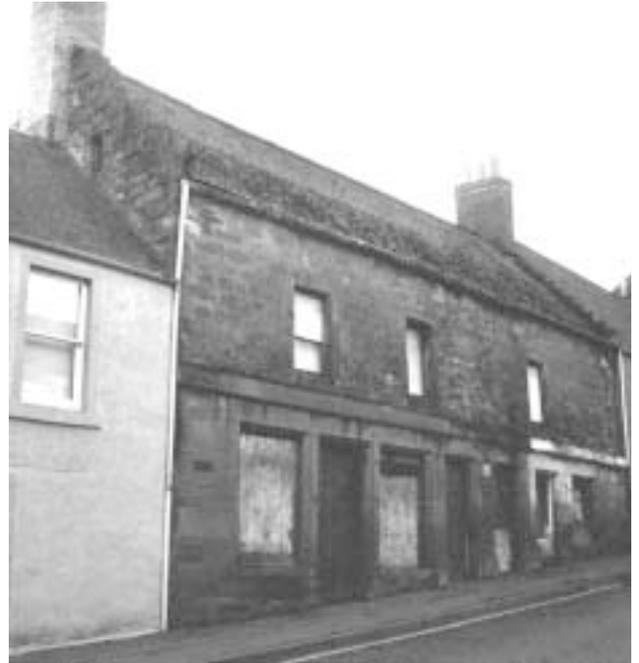
Illus 1 *The frontage of 68-74 High Street.*

The High Street elevation of the building is 2-storey, stone fronted with an asbestos roof, and has crowsteps and brick chimneys on each gable (Illus 1). The crowsteps are the only ones to survive on a domestic building in Brechin. The ground floor has been refaced in ashlar sometime in the mid 19th century when two

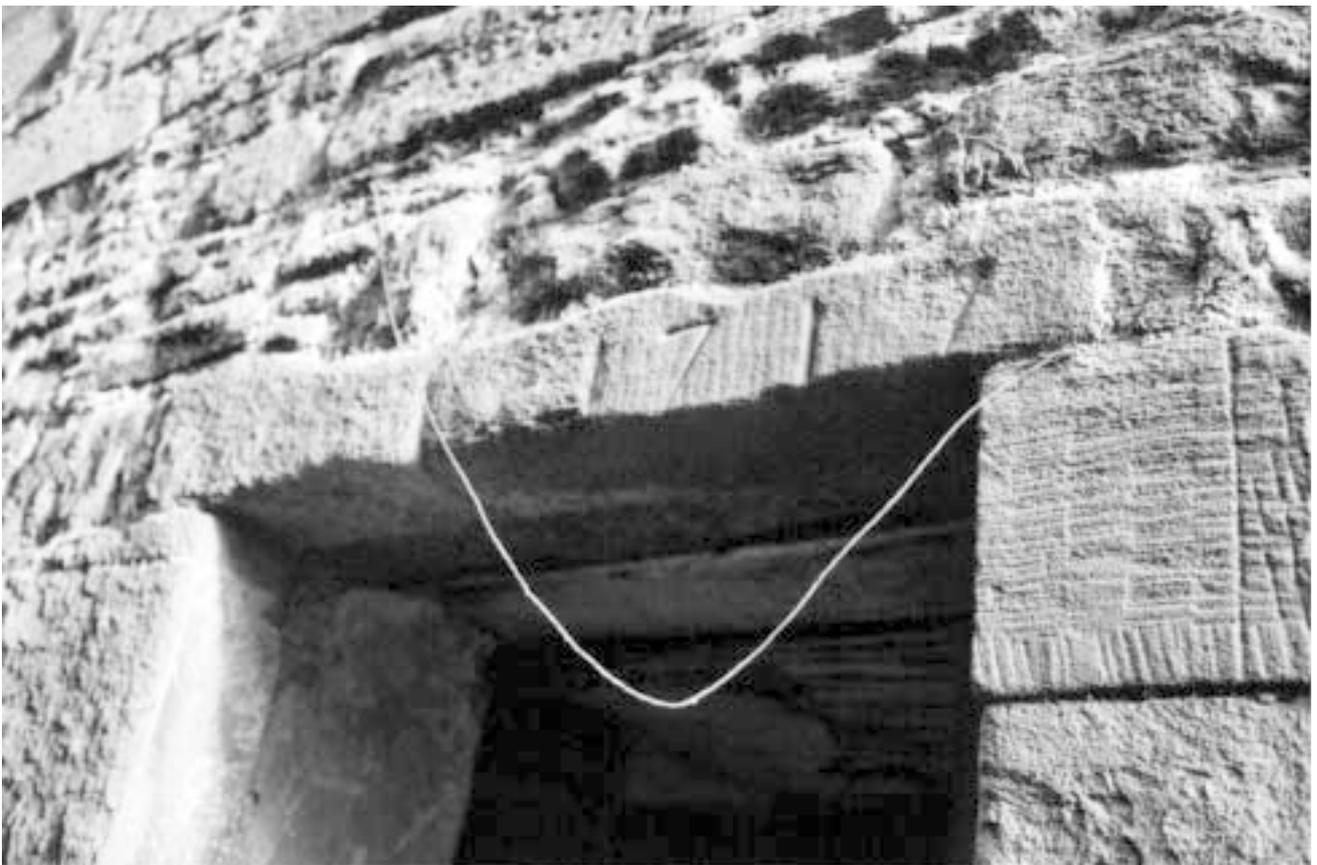
Illus 2 *Date-stone over the doorway into the basement of the southern extension.*

To the rear of the property the garden falls steeply down to Skinners Burn, following the lines of the old rigg system (Gourlay 1977, Map 2). Two free standing extensions were built out into the garden on either side of the pend. The southern extension, which has a basement wash-house, is separated from the adjoining building by a cat run. The basement still contains its 18th century copper boiler and a series of cupboards with good timber doors which probably came from the front building at the time the extension was added. The lintel above the door to the basement is engraved with the date '1717' (Illus 2). The date is offset but appears to be authentic and provides a *terminus ante quem* for the construction of the High Street frontage.

The tree-ring date of AD 1470 provides a *terminus post quem* for the construction of House 2 while the date of '1717' engraved over the basement door to the southern extension provides a *terminus ante quem*. It is unlikely that House 1 would have been dismantled rapidly after construction. If at least half a century is allowed for its occupation then we can surmise that House 2 was built some time between the middle of the 16th century and the end of the 17th century. Documentary sources were examined to see whether the construction date could be narrowed down further.

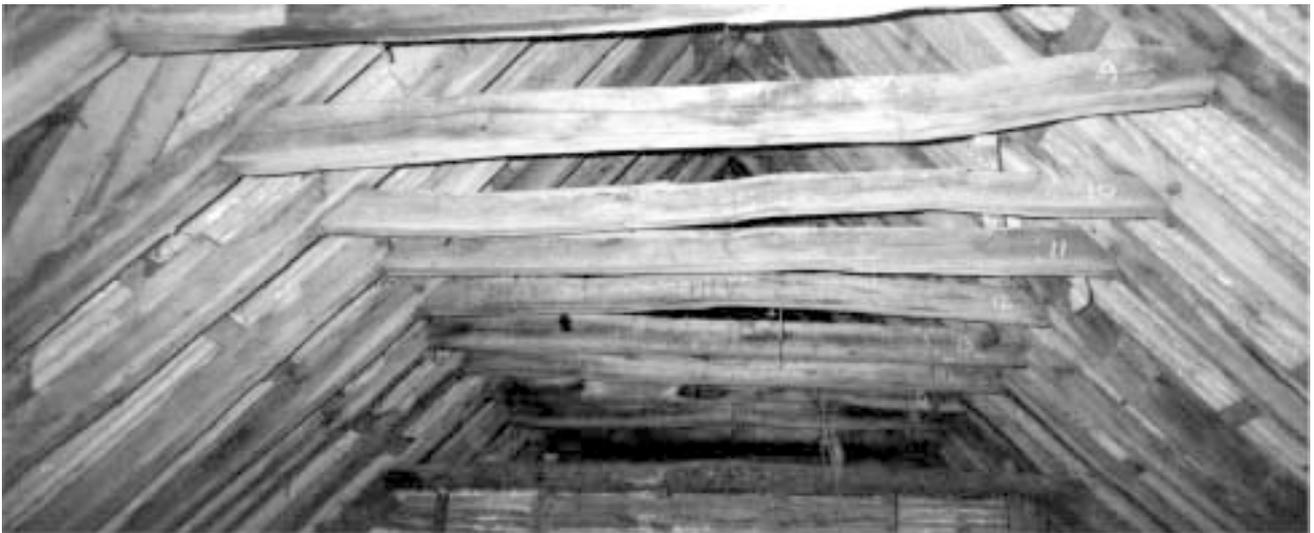
Illus 3 General view of the roof, showing the sequence of contemporary carpenter's marks on the collars.

at a later date. The 1717 extension has retained good window shutters and timber doors but it is the roof space of the original High Street property which, divided into two rooms on either side of a narrow access stair, is of most significance. Interesting alterations have been made to the flues in each gable. They are defined by vertical joints which suggests they were inserted well after the construction of the building possibly to replace wooden flues which had to be removed following a town council edict of 1762. However, by far the building's most important feature is an ashlar post roof with a superb series of assembly, or carpenter's marks (Illus 3).

Several of the timbers also bore two sets of carpenter's marks, one set of which clearly relates to the construction of the House 2 roof (Illus 3 and 4). The other set had been cut using a chisel and were smaller, more deeply incised and more precisely executed (Illus 6 and 12). There are eleven examples of this type (Illus 4), seven located on collars, three on rafters which also bear redundant joints and one of a rafter with no other evidence of re-use. The marks on the collars are all located in exactly the same position, at the very end of the collar (ie Illus 12). None of the marks are identical; as identical marks were cut onto each component of a frame so that they could be assembled correctly the conclusion must be that the bulk of the timber used in House 1 was not used in House 2. Frame 24 bears an unusual mark, a V on its side (Illus 13). The largest number recorded is XXV.

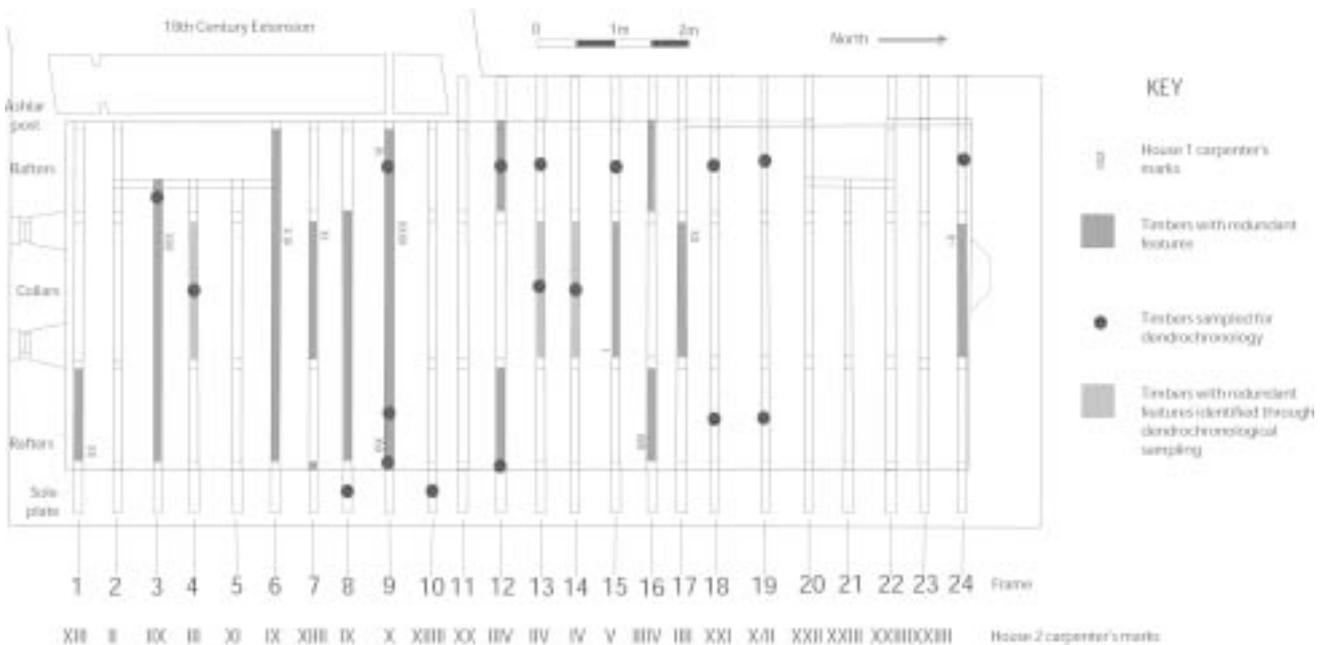
Illus 4 Plan of the roof structure.

The roof consists of twenty-four timber frames, each with paired rafters, a collar beam, ashlar post and sole plate (Illus 4 and 5). All joints were pegged with large projecting trenails which would have been capable of drawing slightly offset boreholes together, ensuring very tight joints. For the purposes of recording and sampling the frames were numbered BR1–24 from south to north, and the components were identified by letter (R = rafter; C = collar; A = ashlar; SP = sole plate). The location within the frame was also recorded (W = west; E = east). Thus, BR19RE is the eastern rafter from Frame 19. The frames all bore large carpenter's marks which had been cut with a race knife and which spanned the width of the timber (Illus 3 and 4). The carpenter's marks did not have tags to differentiate between left and right rafters.

Evidence for re-use was noted on many of the timbers (Illus 4) in the form of redundant joints and duplicate carpenter's marks. These details were fully recorded in case it proved possible to reconstruct the type of building from whence they originally came (see site archive). For clarity the current roof is referred to as House 2, the 'ghost' house represented by the re-used timbers as House 1.

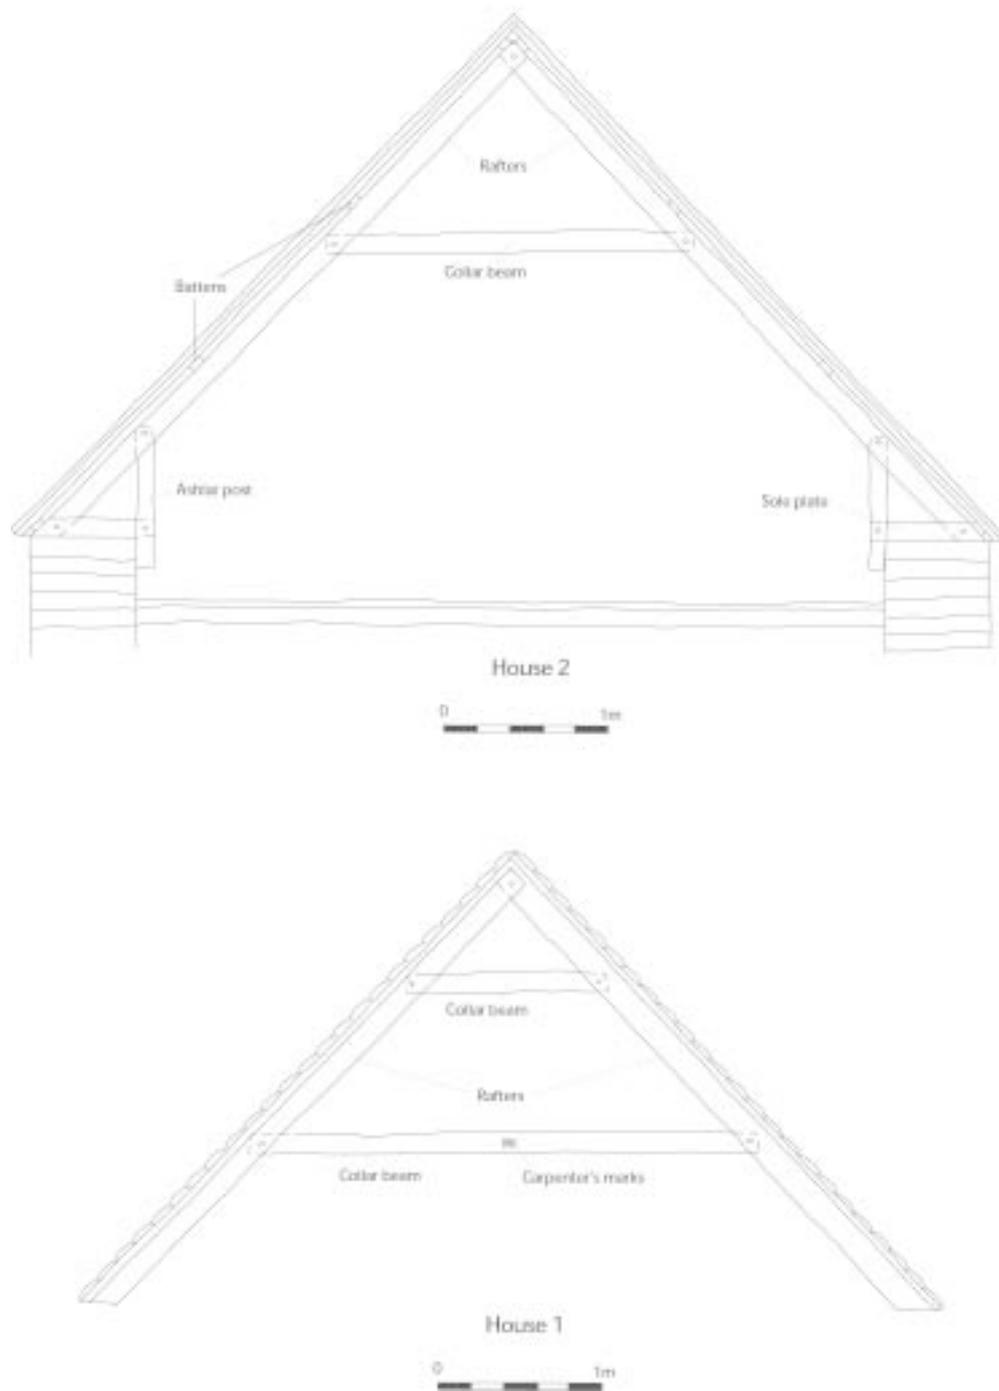
Illus 5 a Cross-section of a frame in House 2. **b** Cross-section of a frame in House 1.

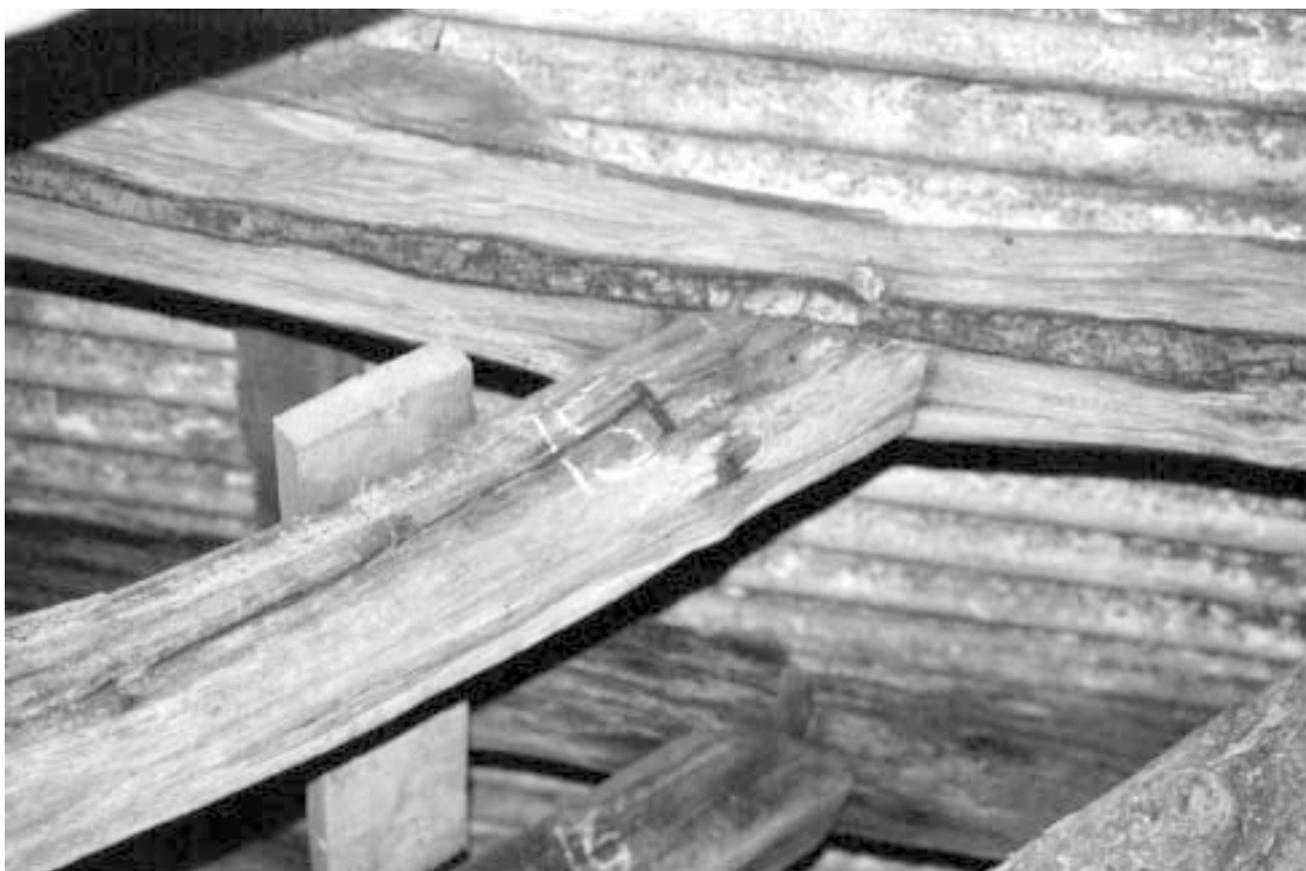
Illus 6 *The carpenter's mark on BR15C. The strips of bark on each corner of BR15RE are visible behind.*

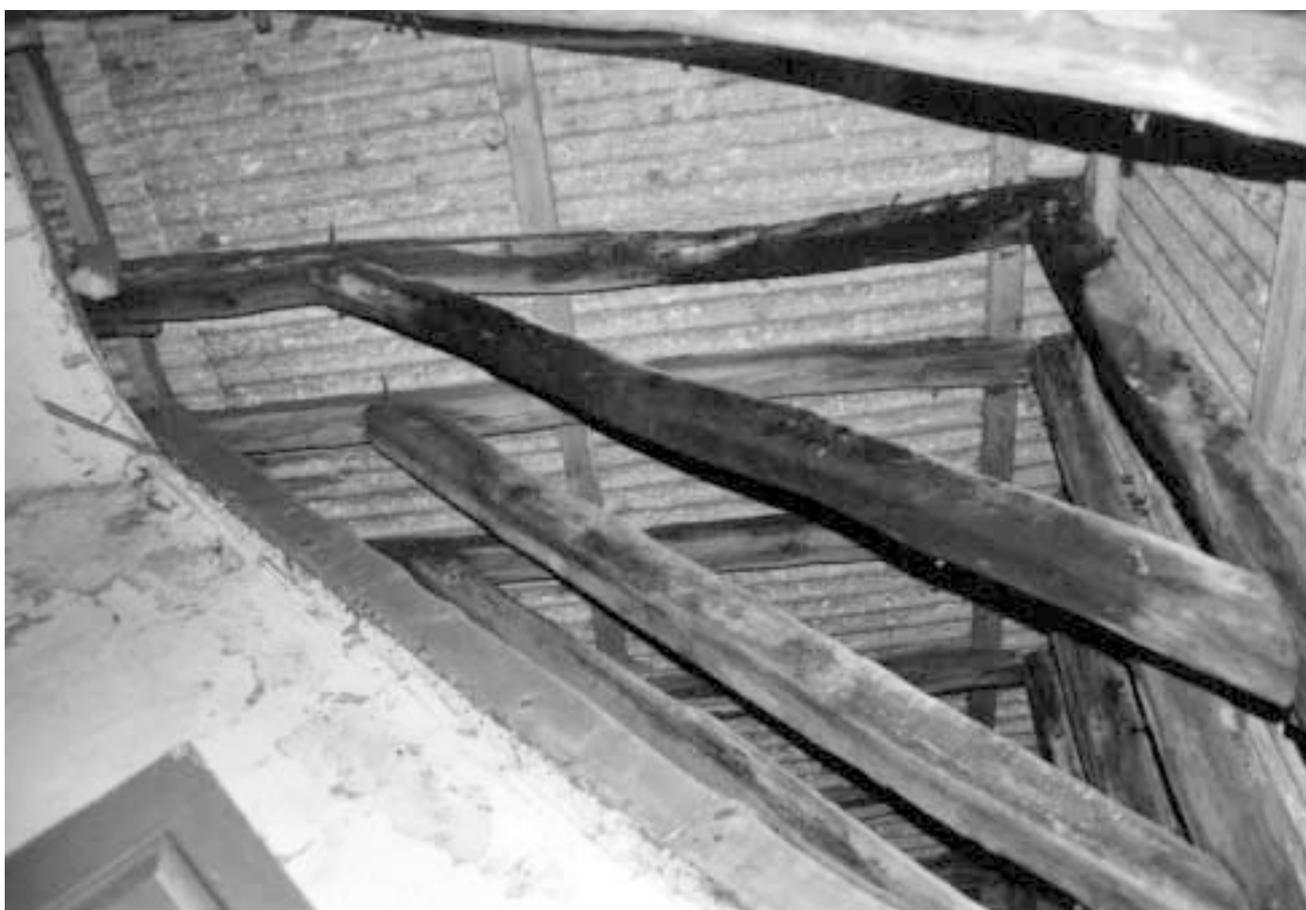
Illus 7 *Soot staining on rafters and collar of Frame BR18.*

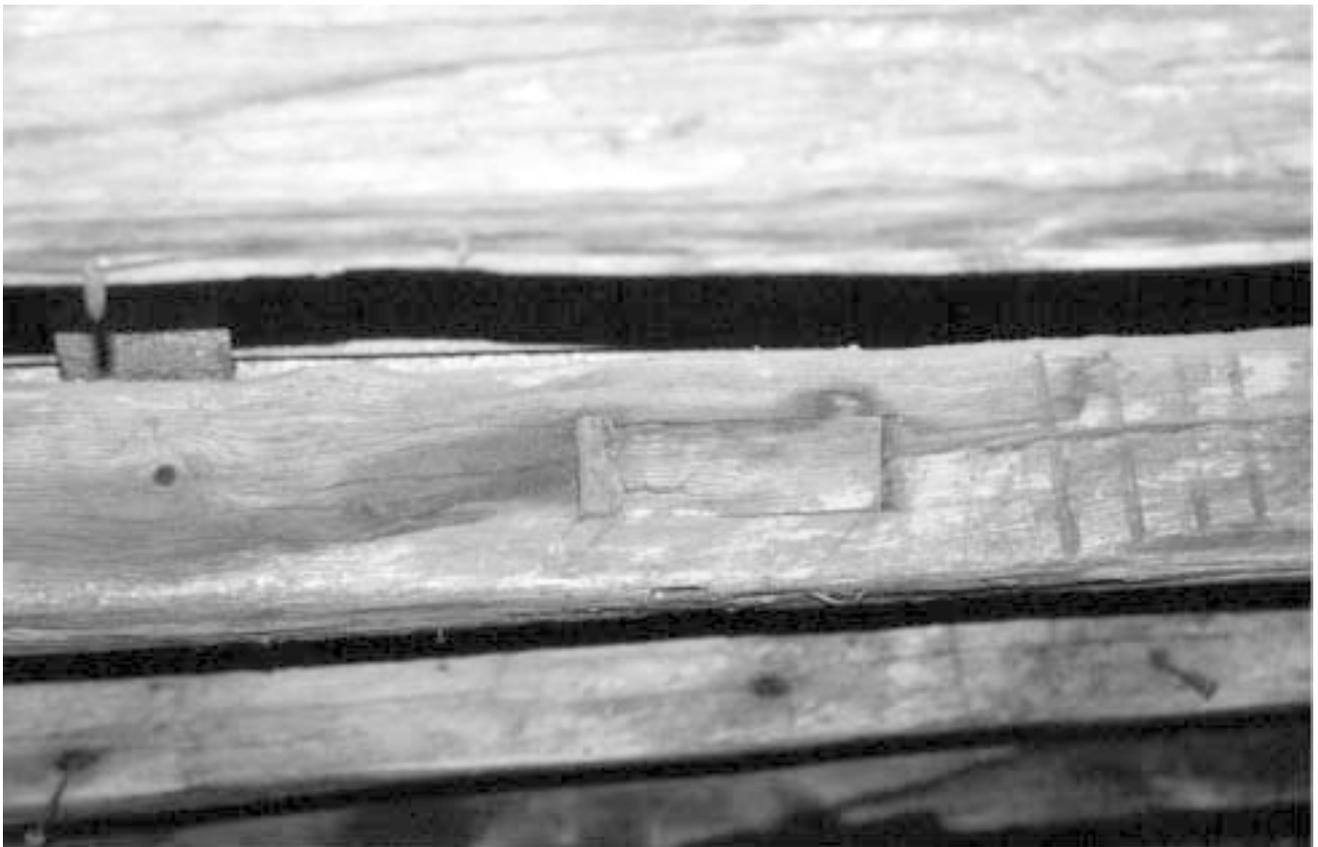
Illus 8 Upper joint on BR16RW, showing a blocked-up mortice. The House 2 carpenter's marks lie to the right of the mortice.

Redundant joints were found on eleven components. The majority of the joints were mortice-and-tenons (M and T). The empty mortices had been filled with blocks, presumably for aesthetic reasons (Illus 8). The mortices were larger and more neatly cut than those in House 2. The end faces of the mortice-holes lay at an angle to the surface of the timber, the upper of the faces lying at a steeper angle than the lower (Illus 9). The M and T joints were invariably found on the rafters, and where the rafters were complete (ie they had not been shortened to accommodate the extension roof) there were two joints on the same face (Illus 9). The joints were 1.36 m apart on average, the steeper angled face of the mortice hole always lying to the top (Illus 10).

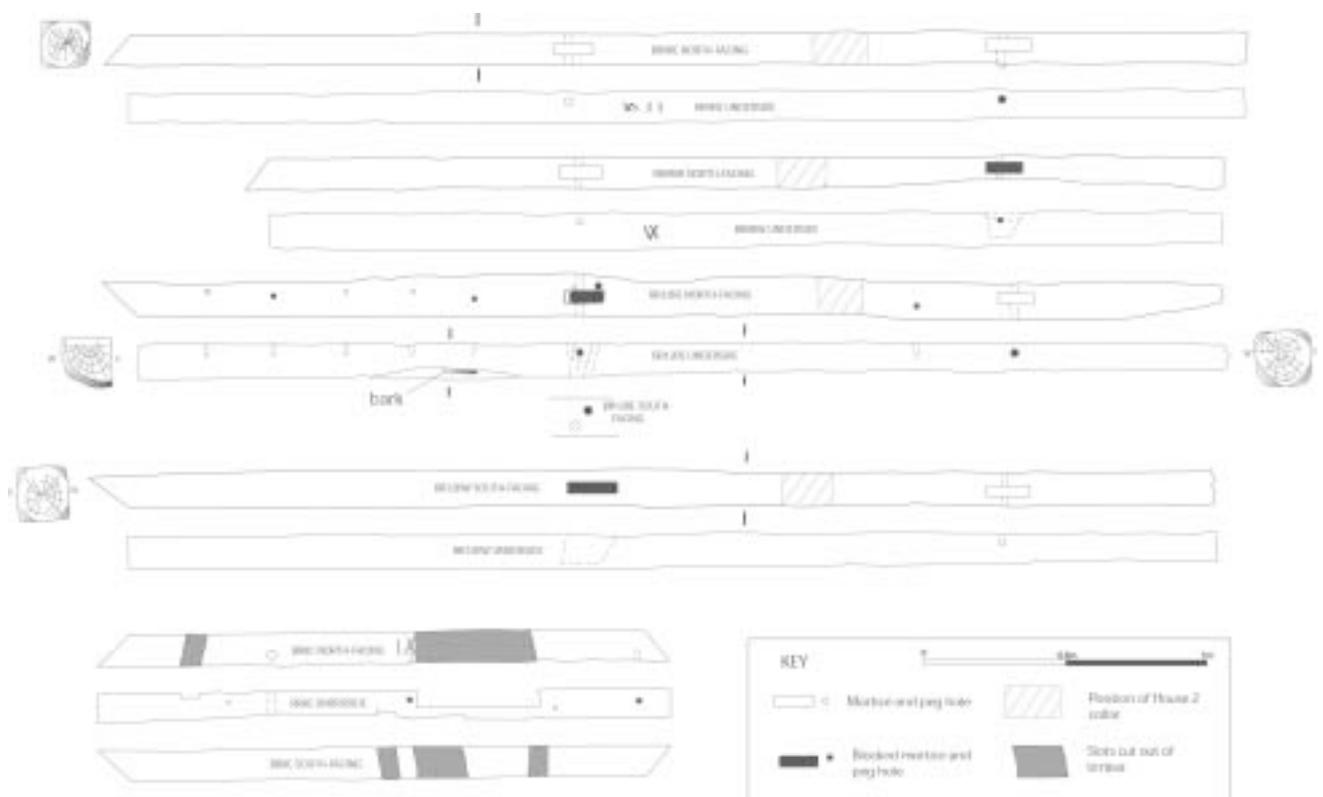
Illus 9 Plans of re-used timbers BR9RE, BR9RW, BR12RE, BR 12RW and BR8C.

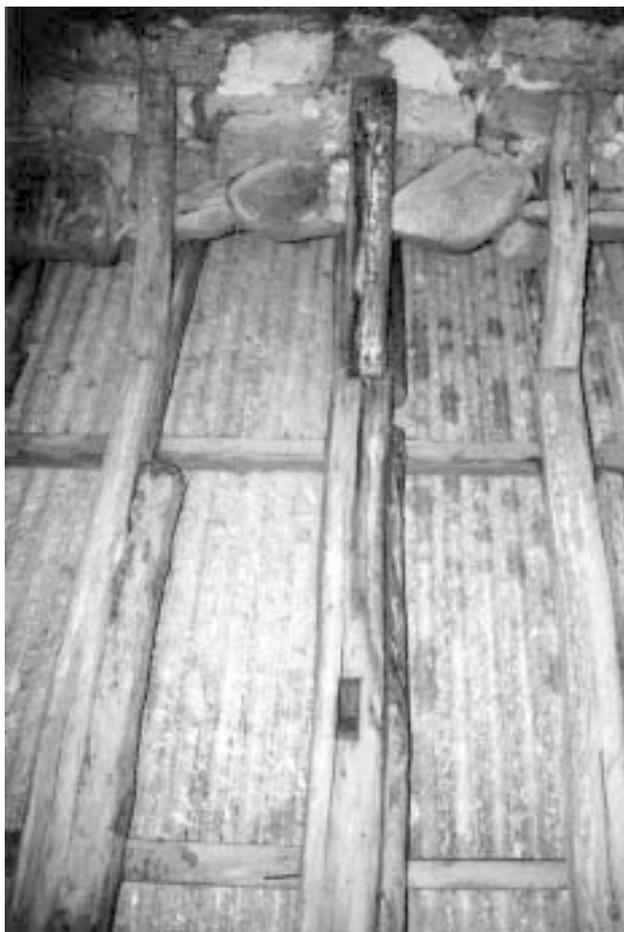
Illus 10 Redundant mortice in BR3RE; the sloping face of the mortice lies to the top of the joint. The ashlar post-construction of House 2 can be clearly seen.

faces, two on one face and three on the other (Illus 10). The notches were of varying width and depth and, although parallel-sided, they lay at angles to the surfaces of the other faces. The largest of the notches clearly relates to the use of House 2, because the House 2 carpenter's marks are cut by it (Illus 9). It is therefore possible that the other notches also relate to the use of House 2. However, the timber is more decayed than others within the roof, suggesting a greater longevity, and also bears an irregular row of small, 10 mm diameter holes on the underside, two of which still have pegs *in situ*.

BR12RE has two MandT joints but one of the joints cuts through a large 25 mm hole, in which the peg is still *in situ* (Illus 10). This suggests that this timber had been re-used even in House 1. Another empty peghole 30 mm in diameter lies close by, in the same plane, and penetrates the width of the timber. There is also a row of smaller holes, c 15 mm in diameter, which lie in the same plane but only penetrate the timber to a depth of 50 mm. Two of these still contain pegs.

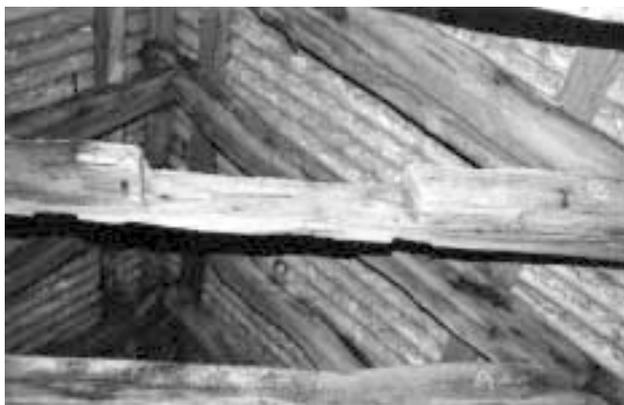
Illus 11 BR8C, showing a large notch cutting House 2 carpenter's marks, which lie just to the left of the notch. The redundant pegholes on the underside of the collar are also visible.

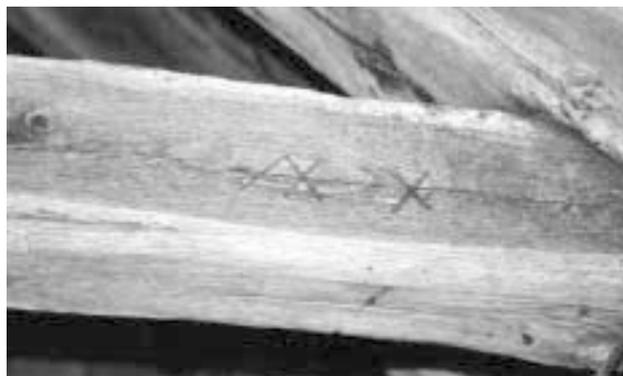
Illus 12 Carpenter's marks on the north face of BR6C. The sapwood on the corners of the boxed heart baulk is clear.

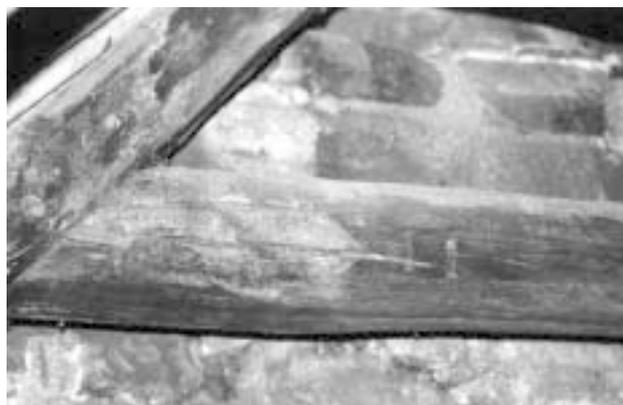
Illus 13 Carpenter's marks on the south face of BR24C.

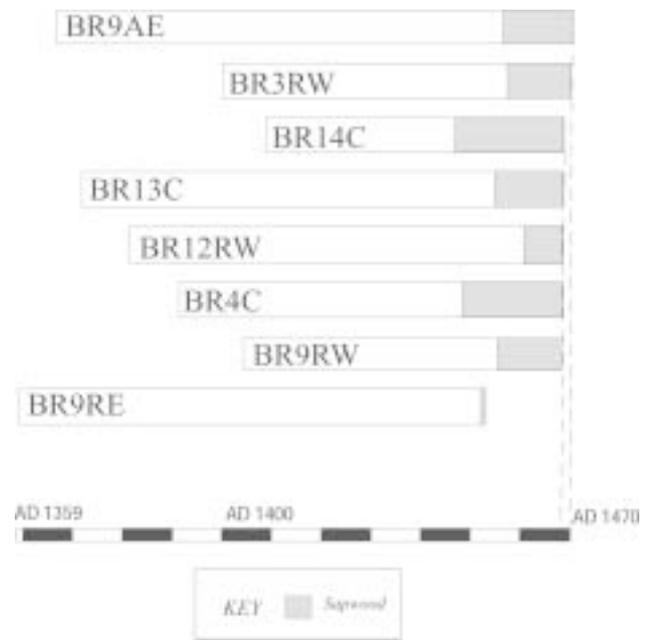
Illus 14 Bar diagram showing the chronological relationships within BRECHIN1.

Each group of sequences was averaged together to form two site chronologies, BRECHIN1 and BRECHIN2, 112 years and 125 years in length respectively (Illus 14 and 15). The two site chronologies did not match each other nor did any of the individual sequences within each chronology match the other chronology. The remaining two sequences, BRJ3 and BR8SPE, did not

With the exception of BR9RE all the components of BRECHIN1 retained the bark edge (Illus 14) and therefore the outermost ring should represent the year in which the tree was felled. The outermost year on BR9RW, BR12RW, BR13C, BR4C and BR14C is dated to AD 1469 while that for BR9AE and BR3RW is the following year, AD 1470. Although the outermost ring on BR14C is dated to AD 1469, the large springwood pores of the next season's growth are just beginning to form, indicating that it was felled early in the spring of AD 1470. It seems most probable that all the timbers were felled early in the spring of 1470, but some had not yet started to lay down the new season's growth.

All the samples from timbers with physical evidence of re-use are components of BRECHIN1 (Illus 143). This, together with their early date implies that all the other components of this site chronology were probably also re-used, despite the fact that they bore no obvious signs of re-use. Furthermore, the implication must be that all the other re-used timber in the roof is of the same date. Thus, House 1 was built in AD 1470.

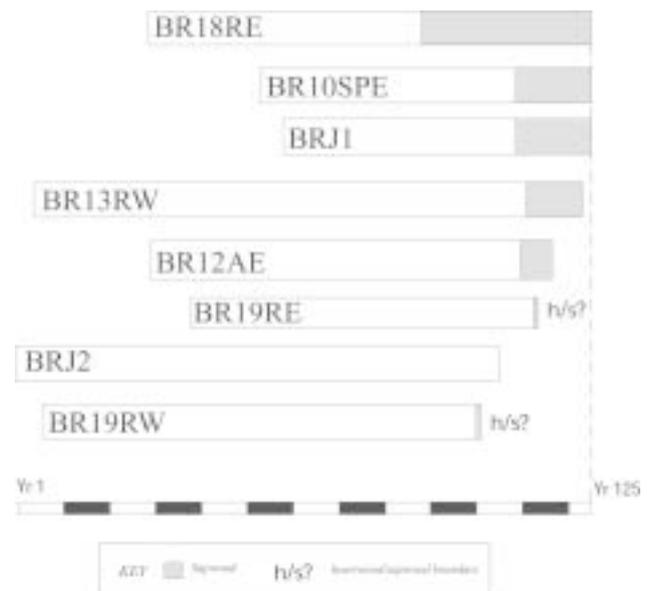
Illus 15 Bar diagram showing the chronological relationships within BRECHIN2.
