Three Perthshire ice houses: selected results of a desk-based assessment and a programme of field investigations

Adrian Cox

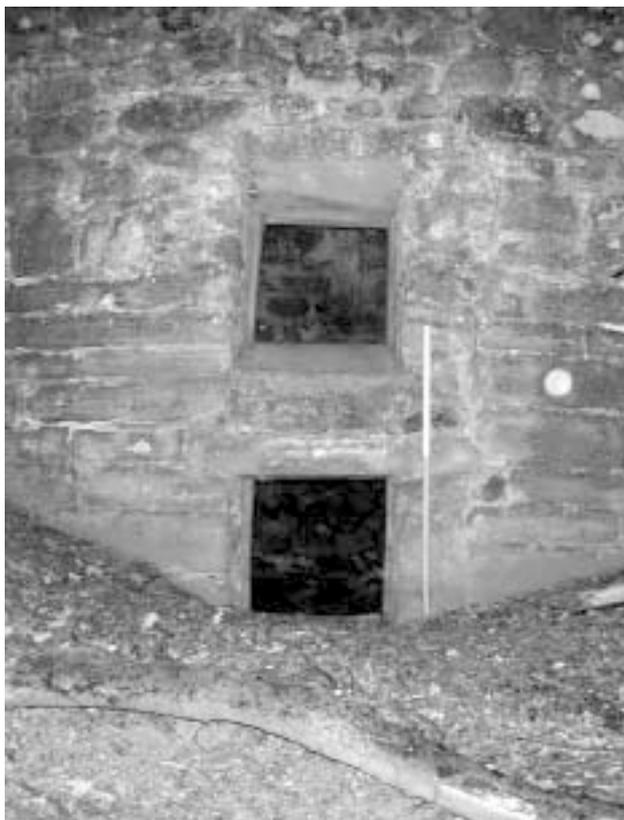
Illus 2 *Monzie Castle ice house, the north face of the structure.*

There are two rectangular openings in the N face (Illus 2). These appear to be modifications to the original structure, which probably had a single entrance. Holes for hinges or bolts associated with an original doorway can be seen in the stonework immediately to the W of the modified openings. Both openings taper inwards. The top of the upper opening is 1.25m below the top of the N face of the structure. It is 0.87m in height externally and 0.59m internally, and has a width of 0.66m. The lower opening is 0.40m below the base of the upper one and is the same width. It measures 0.70m in height externally and 0.64m internally.

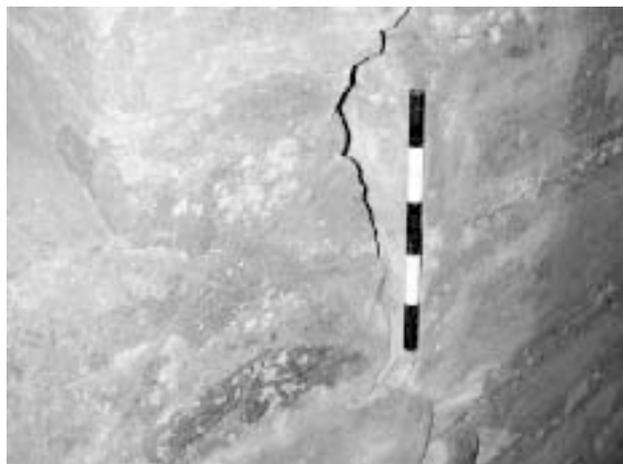
Illus 3 *Crack to the west of the openings in the north face (the scale is in 100 mm divisions).*

The ice house does not appear to be in immediate danger of collapse. Although basically sound at present, it is open to the elements and its condition is likely to deteriorate. A number of potentially significant cracks exist in the structure. These do not appear to represent an immediate threat but could worsen. There is a large crack in the N face, to the W of the openings (Illus 3), and the base of the NE corner of the structure is also damaged, where the coursed rubble side wall meets the dressed stone face. The stonework at the base of the NW corner is also eroded. A further crack runs across the structure from E to W, splitting the concrete cap on both sides. This crack can be traced down the walls. The concrete cap is also cracked (a 30mm gap) at a point around half way along the S wall, and a smaller crack (10mm wide) exists in the capping above the N face, directly above the openings.

The cracks in the structure could be inspected in order to assess their seriousness. Low-level wire mesh fencing around the base of the walls would deter animals from burrowing close to the walls of the structure.

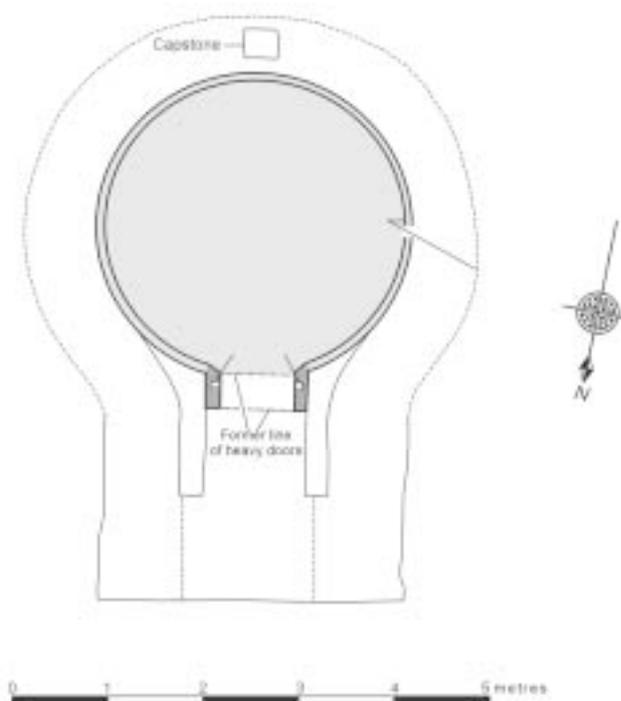
Illus 4 Sketch plan of Dupplin Castle Ice House interior.

The structure is entirely built of dressed stone, and the ice chamber itself is egg-shaped, with a roof of shallow domed form. Illus 4 shows a sketch plan of the interior. Two wooden doors formerly existed within the entrance passage, before one reached the ice chamber. Surviving evidence for these is in the form of large iron hinge pivots set into the stonework (Illus 5), and, in the case of the outer door, strap hinges with remains of wood adhering to them. In addition to the doors, the ice chamber may have been further insulated by removable wooden panelling occupying a vertical groove in the stonework on either side of the passage, immediately adjacent to the chamber. The entrance passage is 1m in width. The ice chamber is approximately 3m in depth below the floor of the entrance passage, and has a central drain, covered by an iron plate (*c* 0.25m in width) at the base. There was almost no debris in the ice chamber on the day of the visit. There is a circular recess at the apex of the ice chamber, approximately 0.20m deep (Illus 6).

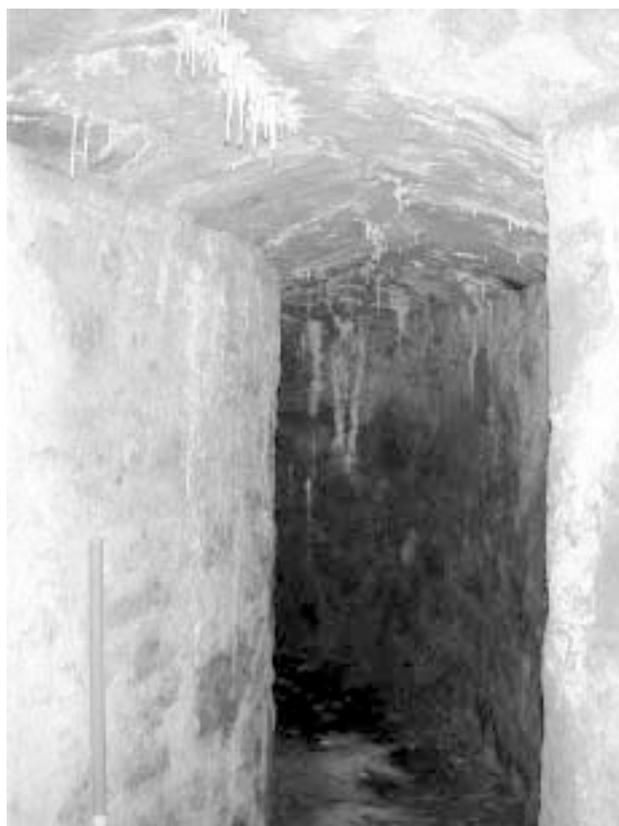
Illus 7 *Dupplin Castle ice house, the encircling passage.*

An unusual aspect of this structure is that it possesses a passage that entirely encircles the ice chamber (Illus 7). This can be entered from either side of the main entrance passage. The encircling passageway is 0.91m in width at the two entrances, narrowing to 0.80m within the curving section around the ice chamber. It has vertical walls and a curved, arched roof, which has been coated with plaster or cement. In the NW and NE corners of the entrance passage, there are traces of attachments to the walls, which may, for example, have formerly held lanterns to light the interior.

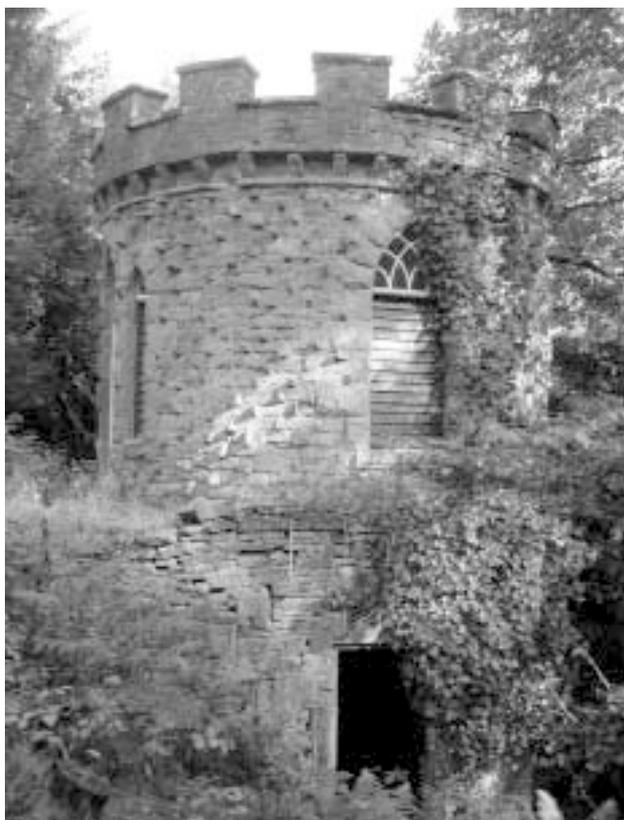
Illus 8 *Invermay House, the entrance to the ice house (bottom of picture).*

This ice house (NO 0612 1610) is situated approximately 40m to the E of Invermay House (NMRS No. NO01NE 85.00), at the top of a steep slope down to the Water of May. The ice house has a game larder, circular in plan, above it (Illus 8).

The ice house is mainly stone-built, but bricks have been used occasionally. Entrance to the structure is from the S or SSE (Illus 8), through a rectangular entrance into a vertical-sided passage with a curved, arched roof. The passage is 2.44m long, 2.28m high and 1.25m wide. There would originally have been an
