# Excavations at 27–35 Panmure Street / 72–8 Murraygate, Dundee

Graeme Brown and Mike Roy

## Location and description (Illus 1 and 2)

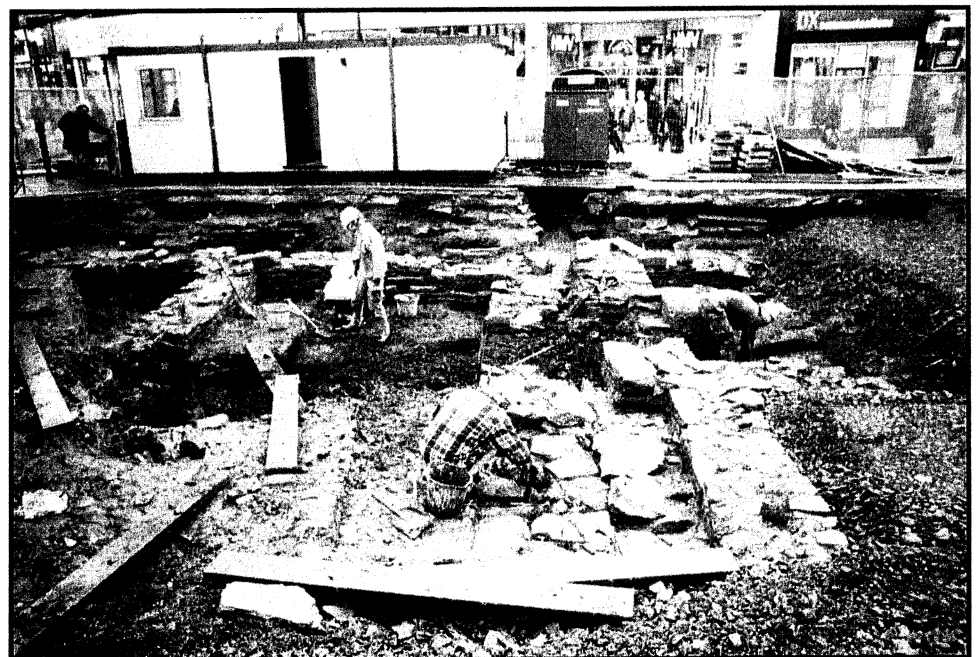
Illus 2 Excavation in progress.

The trial excavations noted above led on almost immediately to a full excavation carried out by a team of five people over three weeks from 30th November to 18th December 1998. The main excavation focused on the area to the north-east of the development because of time constraints and the fact that preservation was likely to be better there than elsewhere. The excavation (site code DD 27) was directed by Graeme H. Brown of SUAT. The area of excavation measured approximately 10m east–west by up to 15m north–south.
