## 3 The excavation: the South Sector

David R Perry

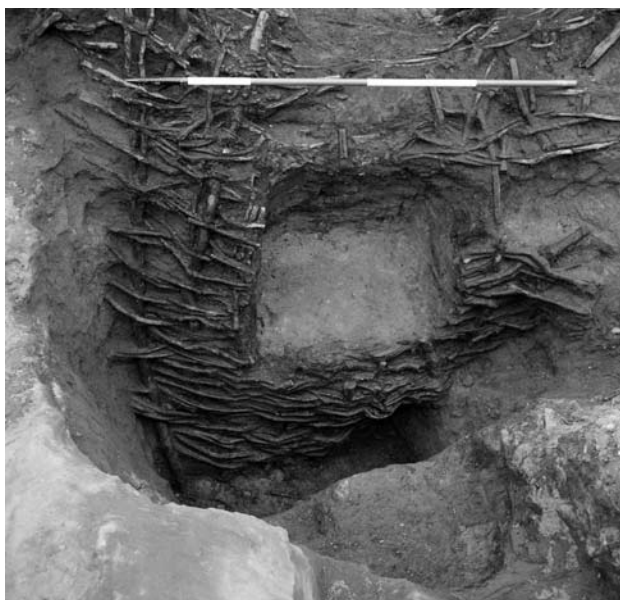
*Illus 20 South Sector: hurdle MW5347 in Pit 5337, looking east. (© Courtesy of RCAHMS. Licensor www.rcahms.gov.uk)*

Pit 5337 had a sloping stake and wattle hurdle (MW5347; Illus 20) on its E side. The hurdle was 2.64m long and 2.6m high along its slope; some of the stakes were paired, but the wattle was not closely woven and was packed in places with moss. Behind the wattle was a layer of sand, which was not excavated. The hurdle may have been a lining to stabilise the E side of the pit after the sand had slumped into the pit; it is unlikely to have been originally a vertical lining on the E edge of the pit pushed in by the collapse of the side of the pit, as the hurdle was intact, not broken, despite the lower part of the hurdle bulging in places as if pushed by the sand behind. In addition to the hurdle in the pit, there were the remains of a 'lid' for the pit in the form of another stake and wattle hurdle and nine horizontal timbers. Several of the timbers had been flattened by the weight of later deposits, which had built up above them. Two of the timbers showed evidence of being reused: one was an oak stake, another was a birch timber with pegs in it. Two radiocarbon dates from finds from this pit produced contradictory dating evidence. Carbon on a sherd of a cooking pot from the fill of this pit produced a radiocarbon date of  $960 \pm 40$ BP (calibrated date AD 990–1170). A piece of leather produced a

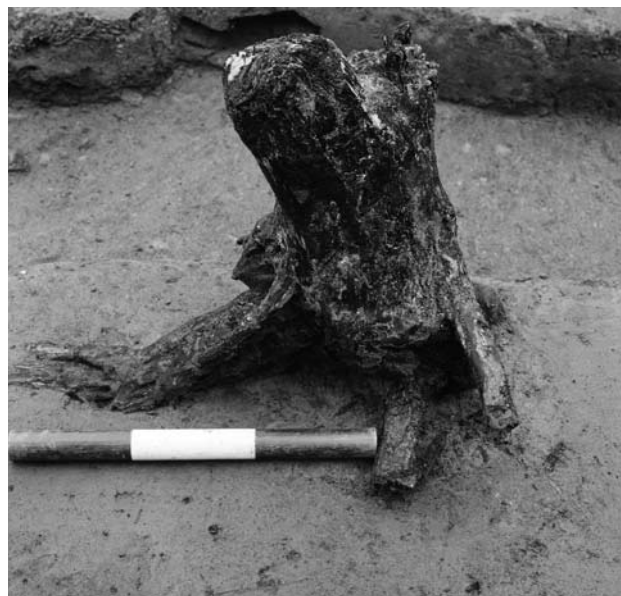
**Illus 23** South Sector: tree stump TS/PP4634, looking west. (© Courtesy of RCAHMS. Licensor [www.rcahms.gov.uk](http://www.rcahms.gov.uk))

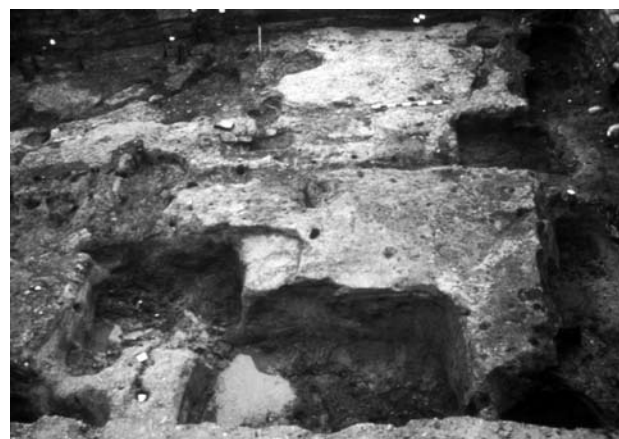
*Illus 26 South Sector: Building 17 on the frontage, looking east. (© Alder Archaeology)*

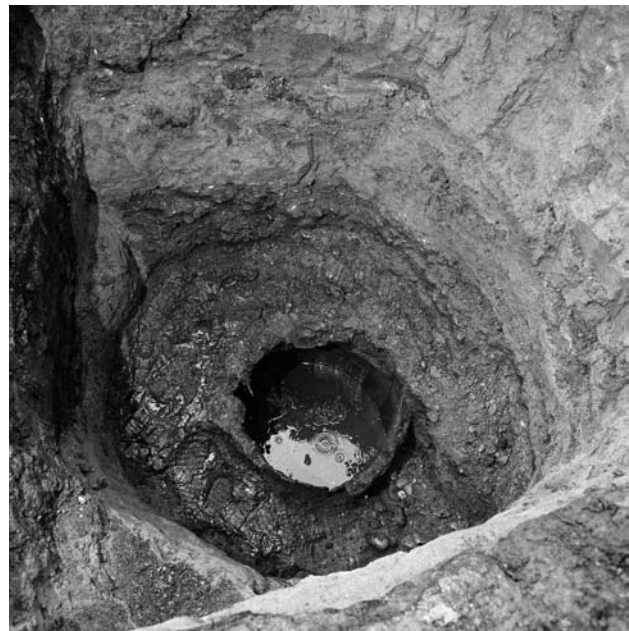
**Illus 29** *South Sector: the barrel well, Well 4774, looking north.* (© Courtesy of RCAHMS. Licensor [www.rcahms.gov.uk](http://www.rcahms.gov.uk))

fence and the barrel was packed with moss, twigs and heather; the space between the fence and the edge of the pit was filled with grey clayey silty loam. The pit was then filled with mixed clay and turf, the space above the barrel being left open to form a well-shaft, 0.75m diameter. No definite lining for the well-shaft was found, although broken pieces of wattle, possibly the remains of a lining, were found pressed down into the waterlogged fill of the barrel. After the well had gone out of use, it became a cesspit, the shaft being filled with reddish brown and yellowish-brown straw and dung with patches of clay. Few finds were recovered from the well-pit or shaft. The barrel, a reused French wine barrel, has been dated by dendrochronology to 1136 or later (Crone 2005, 72). A radiocarbon date of  $895 \pm 55$ BP (calibrated to AD 1020–1250) was also obtained from the barrel.

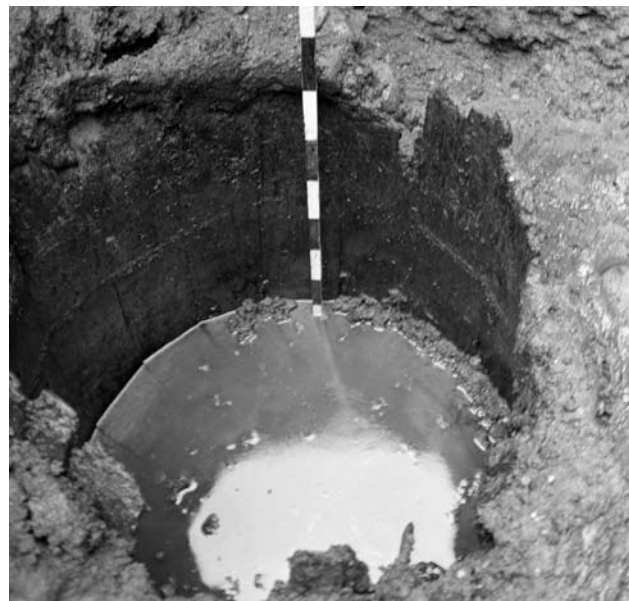
**Illus 30** *South Sector: detail of the barrel MW4772.* (© Courtesy of RCAHMS. Licensor [www.rcahms.gov.uk](http://www.rcahms.gov.uk))

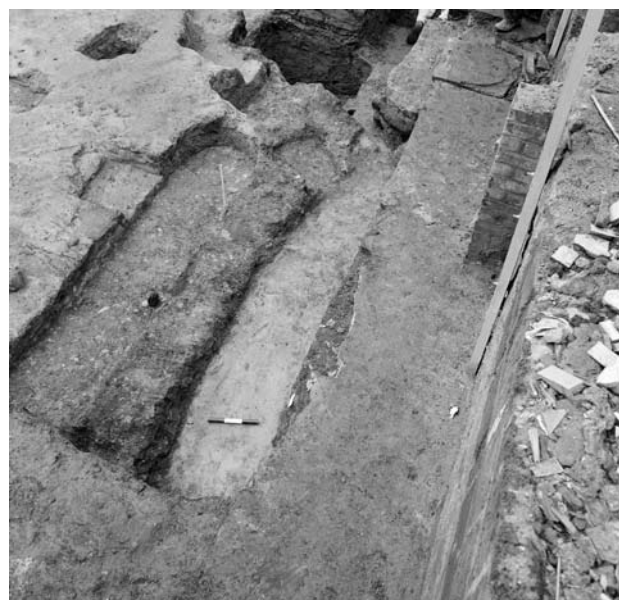
**Illus 32** *South Sector: two possible wall trenches of frontage buildings, T3071 and T3053, looking north-east. (© Courtesy of RCAHMS. Licensor [www.rcahms.gov.uk](http://www.rcahms.gov.uk))*

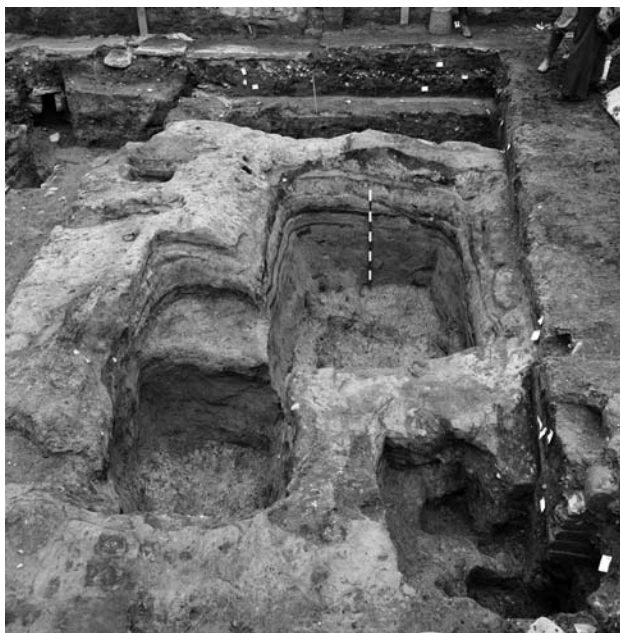
**Illus 33** *South Sector: Pits 3040 (left), 3125 (right background) and 3142 (right foreground) on the frontage, looking south. (© Courtesy of RCAHMS. Licensor www.rcahms.gov.uk)*

Pit 3040 was sealed beneath deposits of sand and clay. It is possible that the ‘seal’ was in fact a sequence of later floors and occupation levels which had slumped into the pit. This is suggested by the presence of two apparent hearths (H3068, H3072) within the ‘seal’ of the pit. On the edge of the pit, in one of its ‘floor’ levels, were three postholes (PH3084A–C; not illustrated).

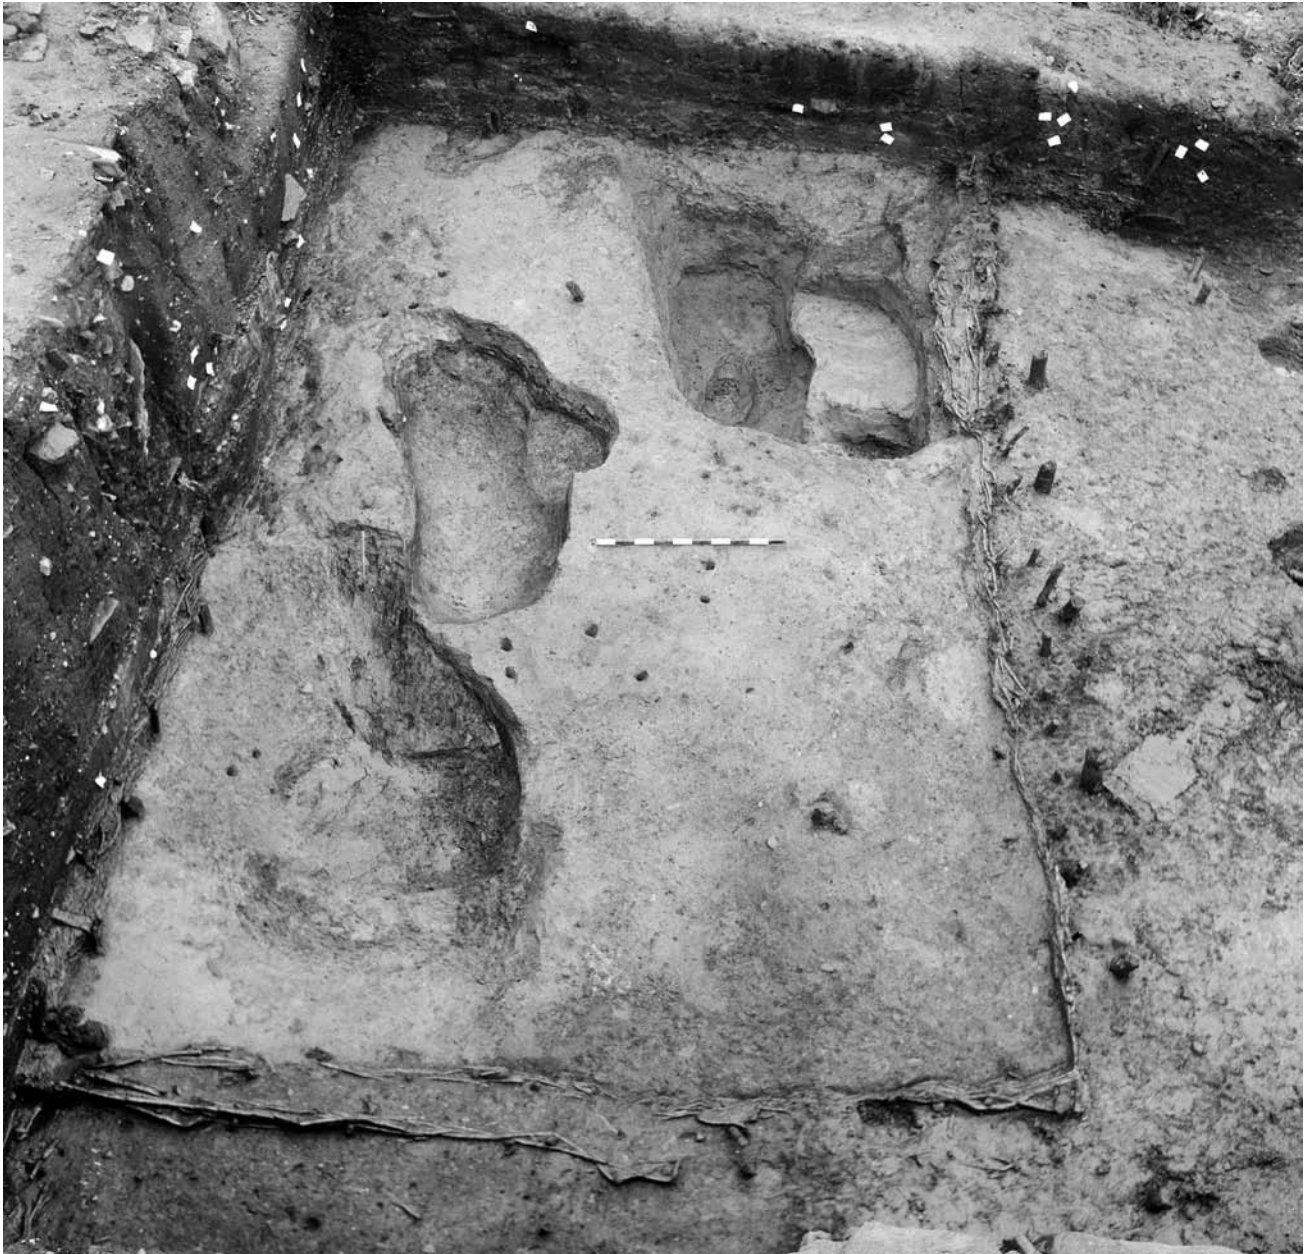
Illus 34 South Sector: Building 16 (Phase 1), looking south. (© Courtesy of RCAHMS. Licensor [www.rcahms.gov.uk](http://www.rcahms.gov.uk))

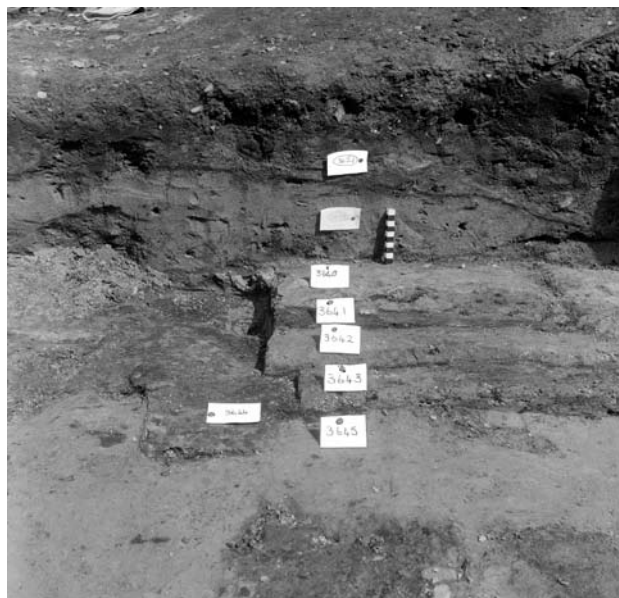
**Illus 36** *South Sector: succession of floor and occupation layers of Building 6 (Phase 1) in east section. Contexts 3619 and 3621 are in vertical plane, the rest horizontal (scale in centimetres). (© Courtesy of RCAHMS. Licensor [www.rcahms.gov.uk](http://www.rcahms.gov.uk))*

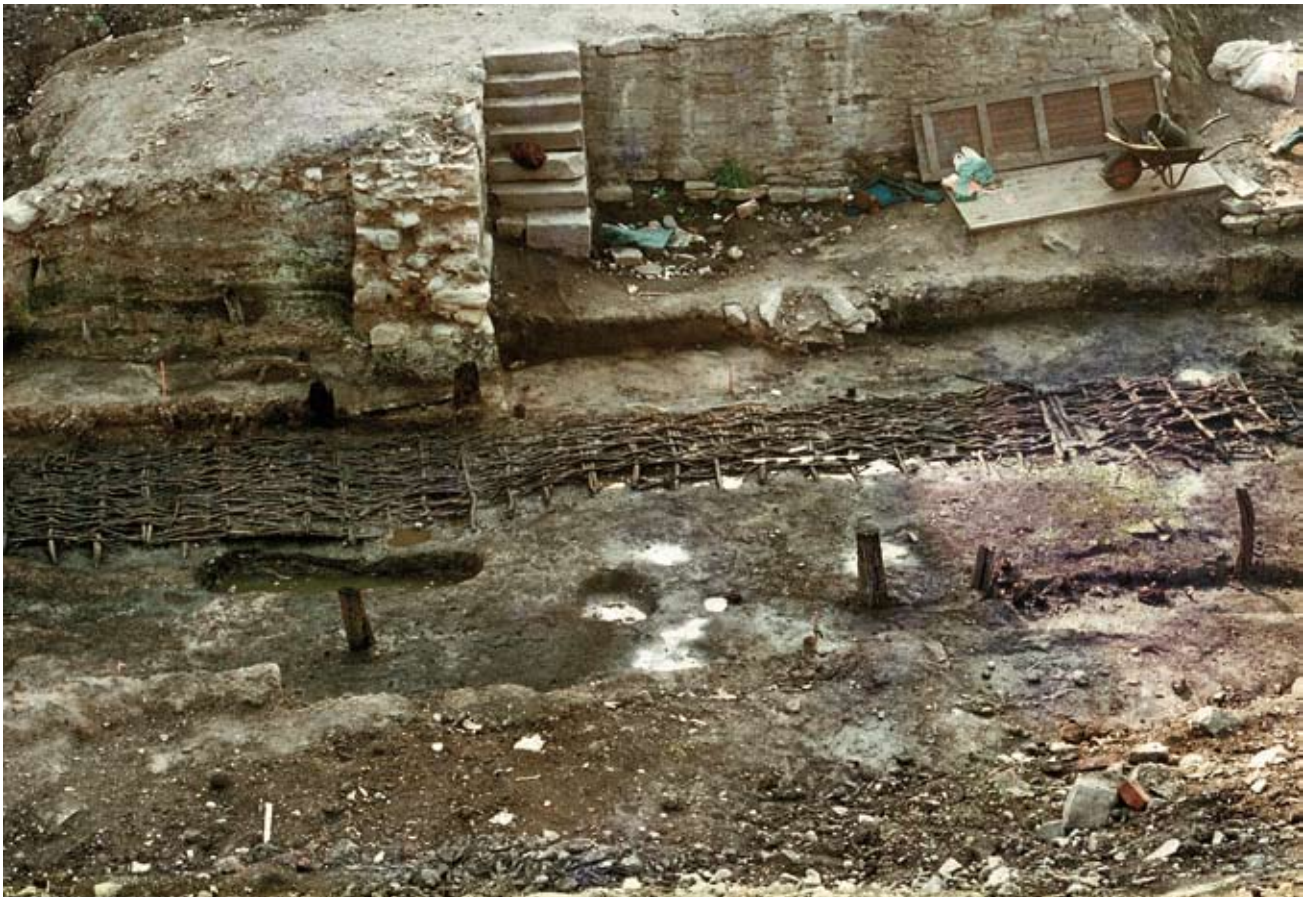
**Illus 38** South Sector: wattle hurdle MW3614 in Path 5.3a, looking east (doorway of Building 6 in background and roof posts of Building 5 in foreground). (© Courtesy of RCAHMS. Licensor [www.rcahms.gov.uk](http://www.rcahms.gov.uk))

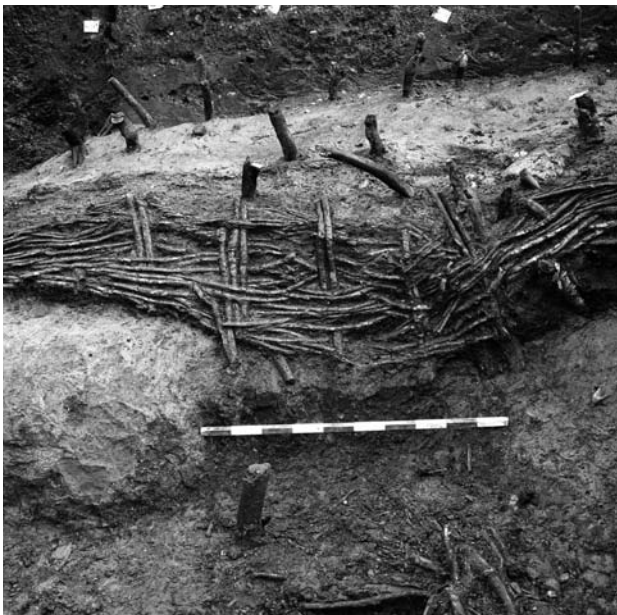
**Illus 39** South Sector: wattle fence WW5316 with groups of two, three or four uprights, looking east. (© Courtesy of RCAHMS. Licensor [www.rcahms.gov.uk](http://www.rcahms.gov.uk))

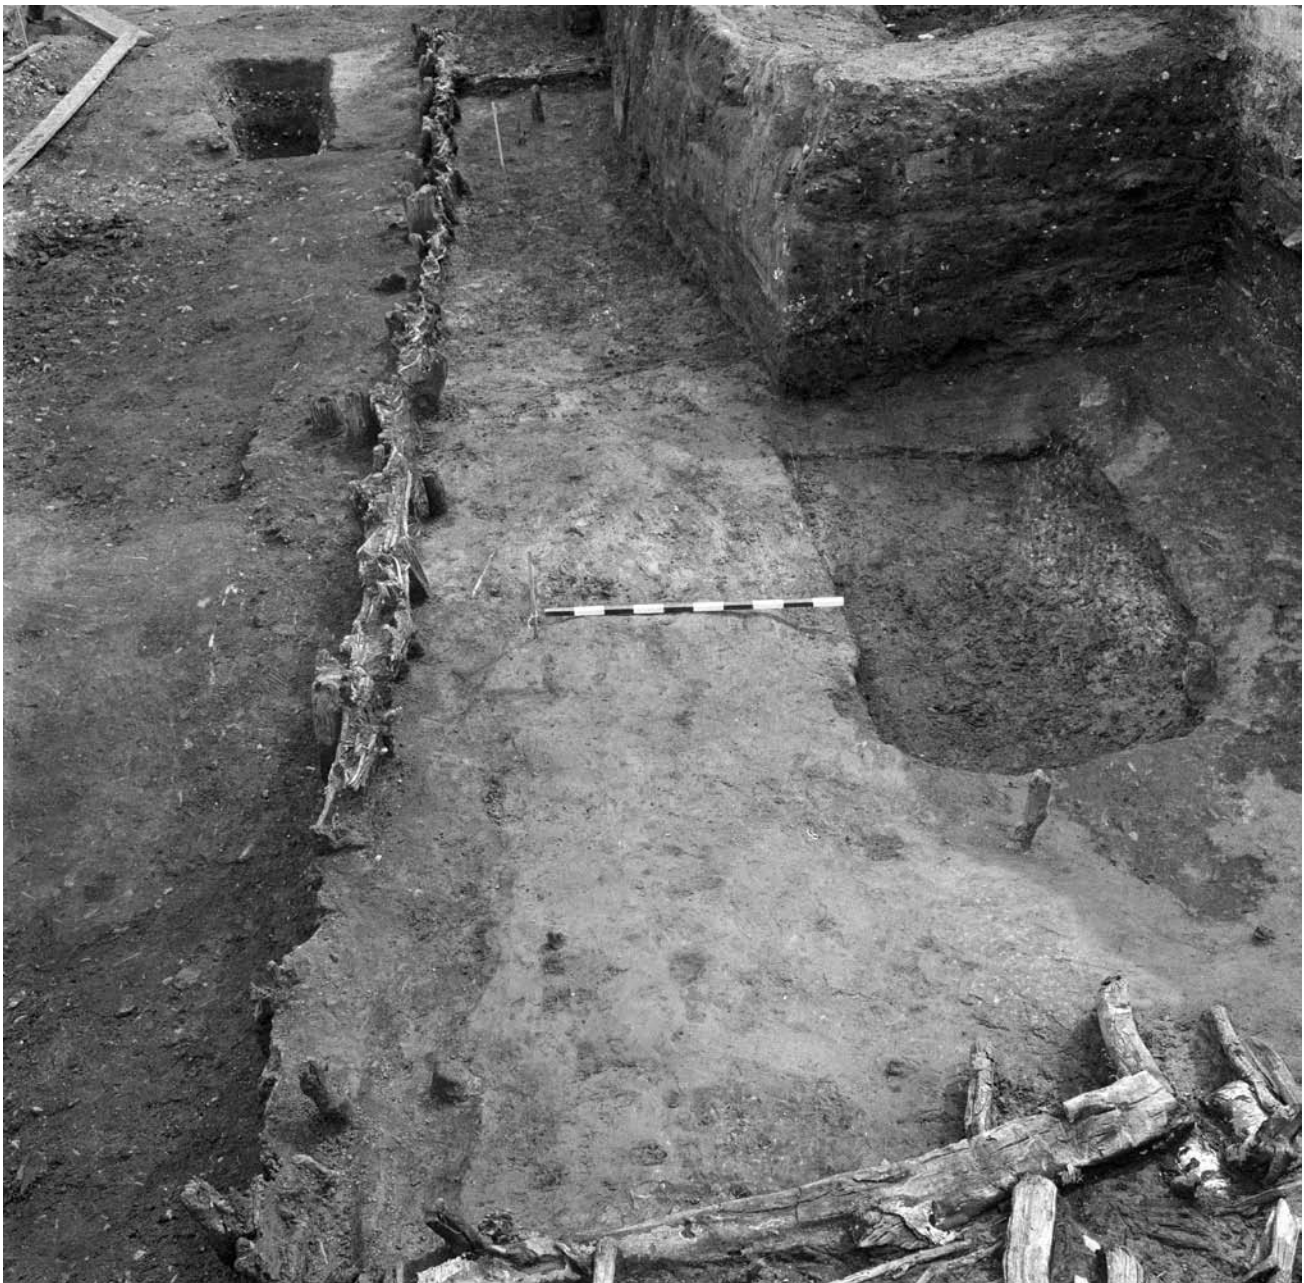
**Illus 41** *South Sector: the north room of Building 5 (in Area 2), looking south. (© Courtesy of RCAHMS. Licensor [www.rcahms.gov.uk](http://www.rcahms.gov.uk))*

In Rig V Building 5 (Illus 41) replaced M14b(c). This building is of crucial importance for dating the earlier phases of the excavation as two of the large oak posts from the E wall were dated by dendrochronology to AD 1150–51 and a further two oak posts from the N wall provided the same dendrochronological dates of AD 1150–51. A third oak post from the N wall provided an estimated date of AD 1155±9, which fits with the other four posts from this building. All the dates provide a construction date for this building of about 1150 (Appendix 5). The size of the uprights along the N and E walls implies a strong, well-built structure that could have lasted for a considerable length of time, until it was burnt down in a fire, possibly as late as Phase IIff. The burning was evident in the charring of the E wall, which had a bank of ash on its E side (C3597) and some of the burnt uprights. Unfortunately, it is not clear whether the building extended as far as the street or was erected behind a separate building on the street frontage.

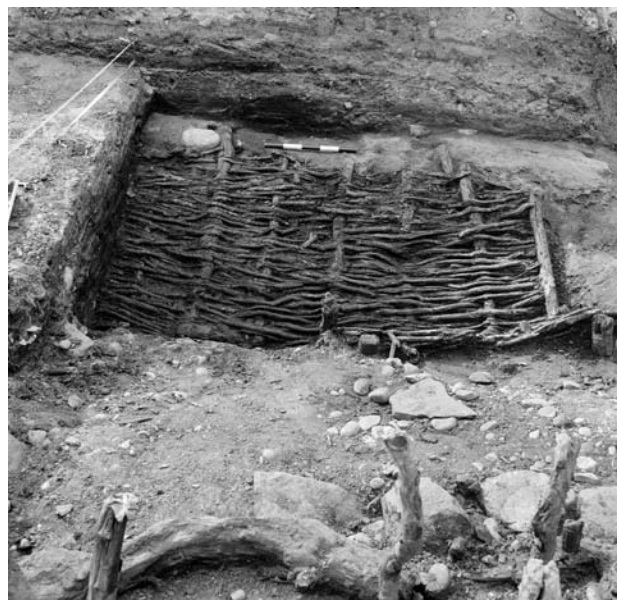
**Illus 43** *South Sector: hurdle MW2622 in Building 23, looking west. (© Courtesy of RCAHMS. Licensor www.rcahms.gov.uk)*

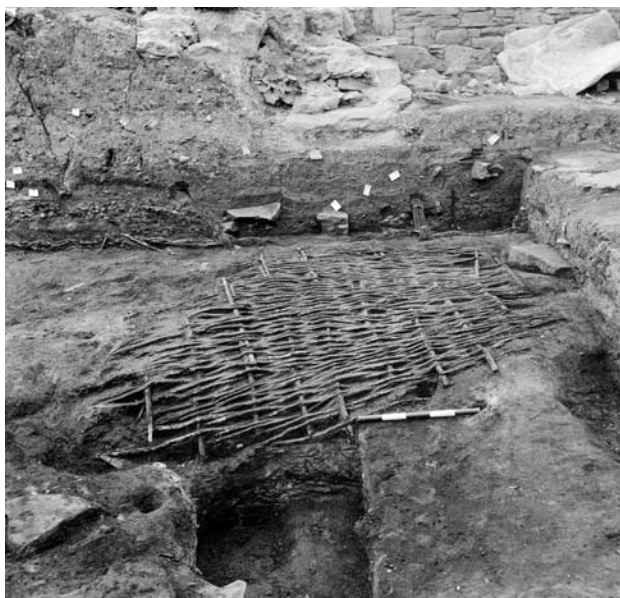
**Illus 47** South Sector: hurdle MW2284 in Building 12, looking east. (© Courtesy of RCAHMS. Licensor [www.rcahms.gov.uk](http://www.rcahms.gov.uk))

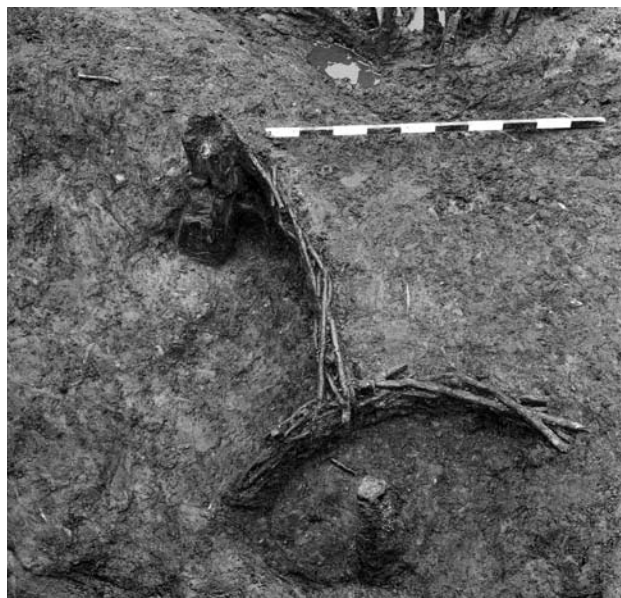
**Illus 48** South Sector: two adjoining curvilinear fences, WW4499 and WW4501, in Midden 1.1a, looking north. (© Courtesy RCAHMS. Licensor [www.rcahms.gov.uk](http://www.rcahms.gov.uk))

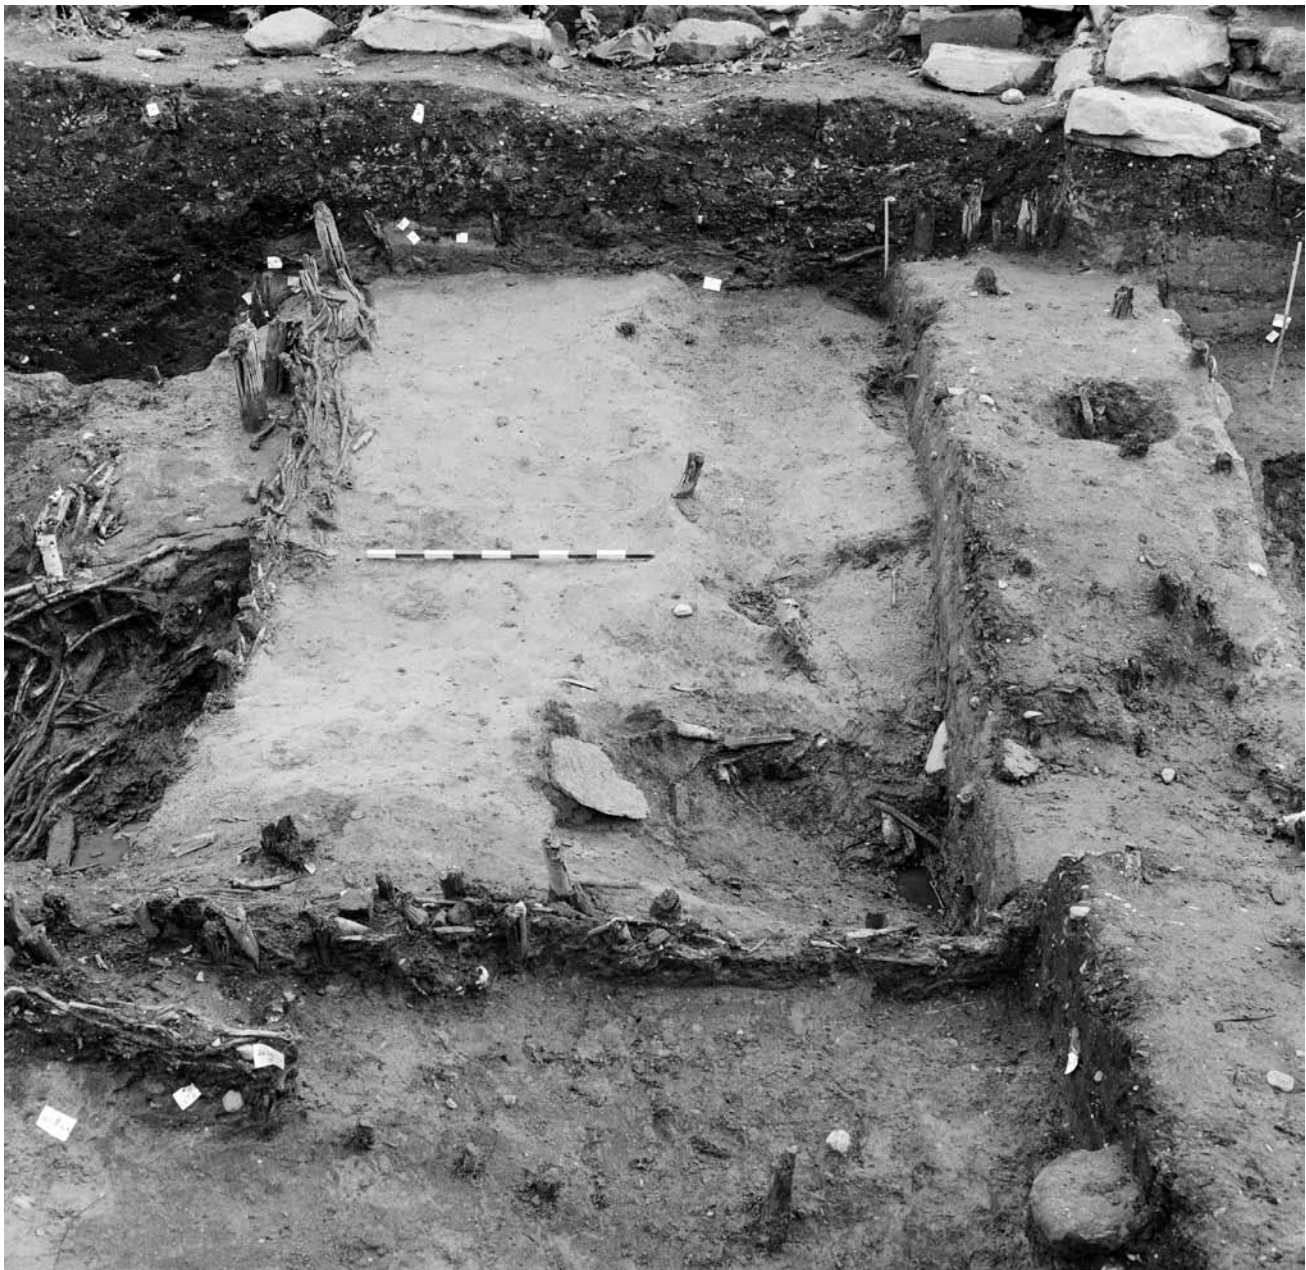
**Illus 51** *South Sector: northern part of Building 21, looking east.*  
(© Courtesy of RCAHMS. Licensor [www.rcahms.gov.uk](http://www.rcahms.gov.uk))

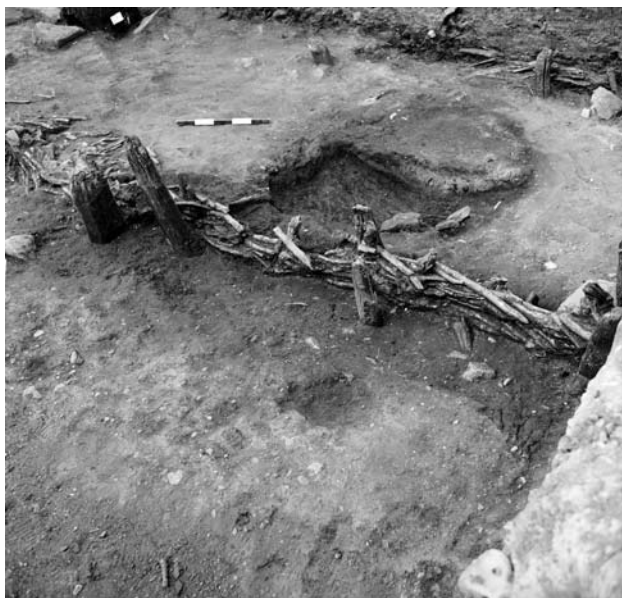
**Illus 55** South Sector: possible structure (CG173) with Pit 2504, looking north-west. (© Courtesy of RCAHMS. Licensor [www.rcahms.gov.uk](http://www.rcahms.gov.uk))

In the midden was a possible structure (CG173; The buildings). This comprised two parallel fence lines (WW2489 and WW2605), 1.7m apart, with some larger posts (PP2470, PP4453). Post PP4653 (Illus 56 and 59–61) may also have been associated with the N wall. Fence WW2489 was recorded as set in a trench filled with grey clay (C2509), but this may have been a clay daub for the wall (The buildings). Between the two fences was a shallow pit (Pit 2504), 0.35m deep, filled with black organic loam with tiny woodchips and grass, brown sand, pale grey sand, hard dark brown clay and orange, grey and black burnt clay and sand. The pit may have been a latrine within a shelter (Illus 55). Post PP2470 was an oak post with a roughly dressed and burnt base; around it were packing stones (C2594). This post provided a dendrochronological date of 1193–4 (Appendix 5). This date ties in well with

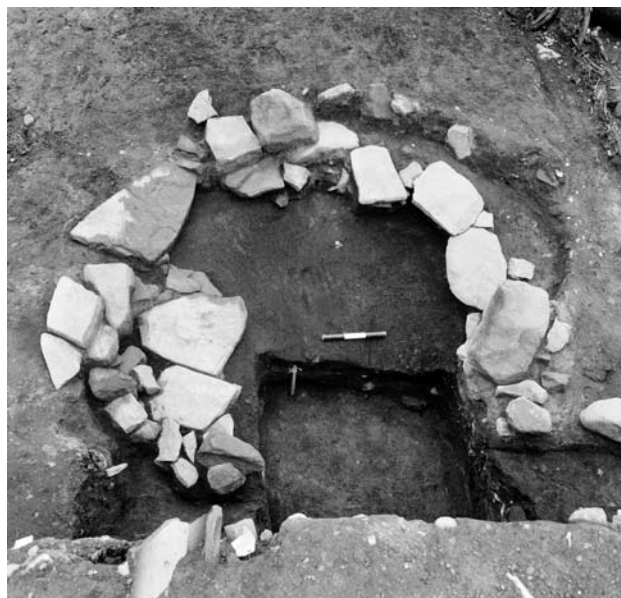
**Illus 57** South Sector: stone hearth H2220 in Midden 1.4a, looking west. (© Courtesy of RCAHMS. Licensor [www.rcahms.gov.uk](http://www.rcahms.gov.uk))

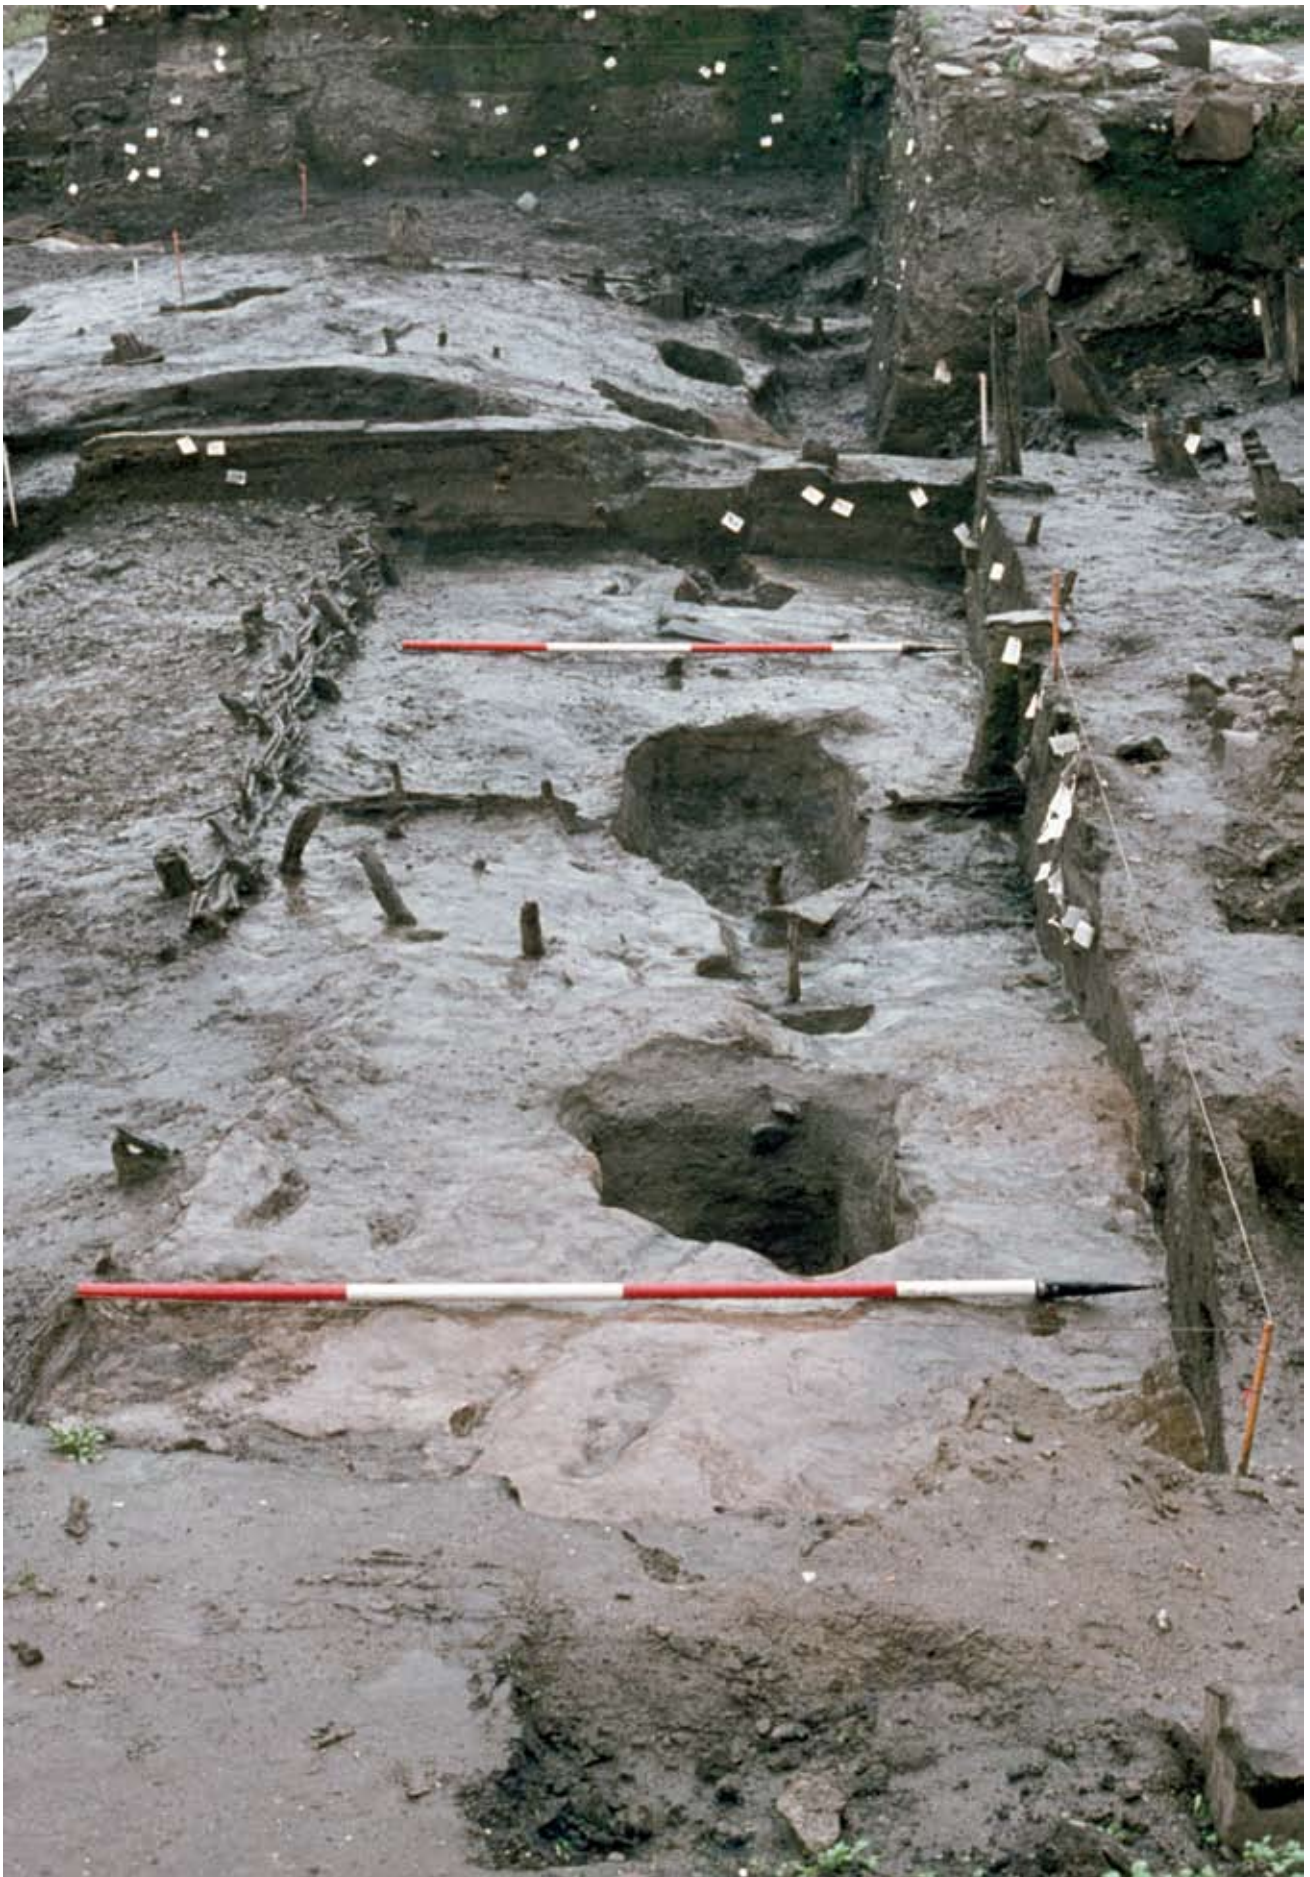
Illus 58 South Sector: Building 19, looking north. (© Courtesy of RCAHMS. Licensor [www.rcahms.gov.uk](http://www.rcahms.gov.uk))

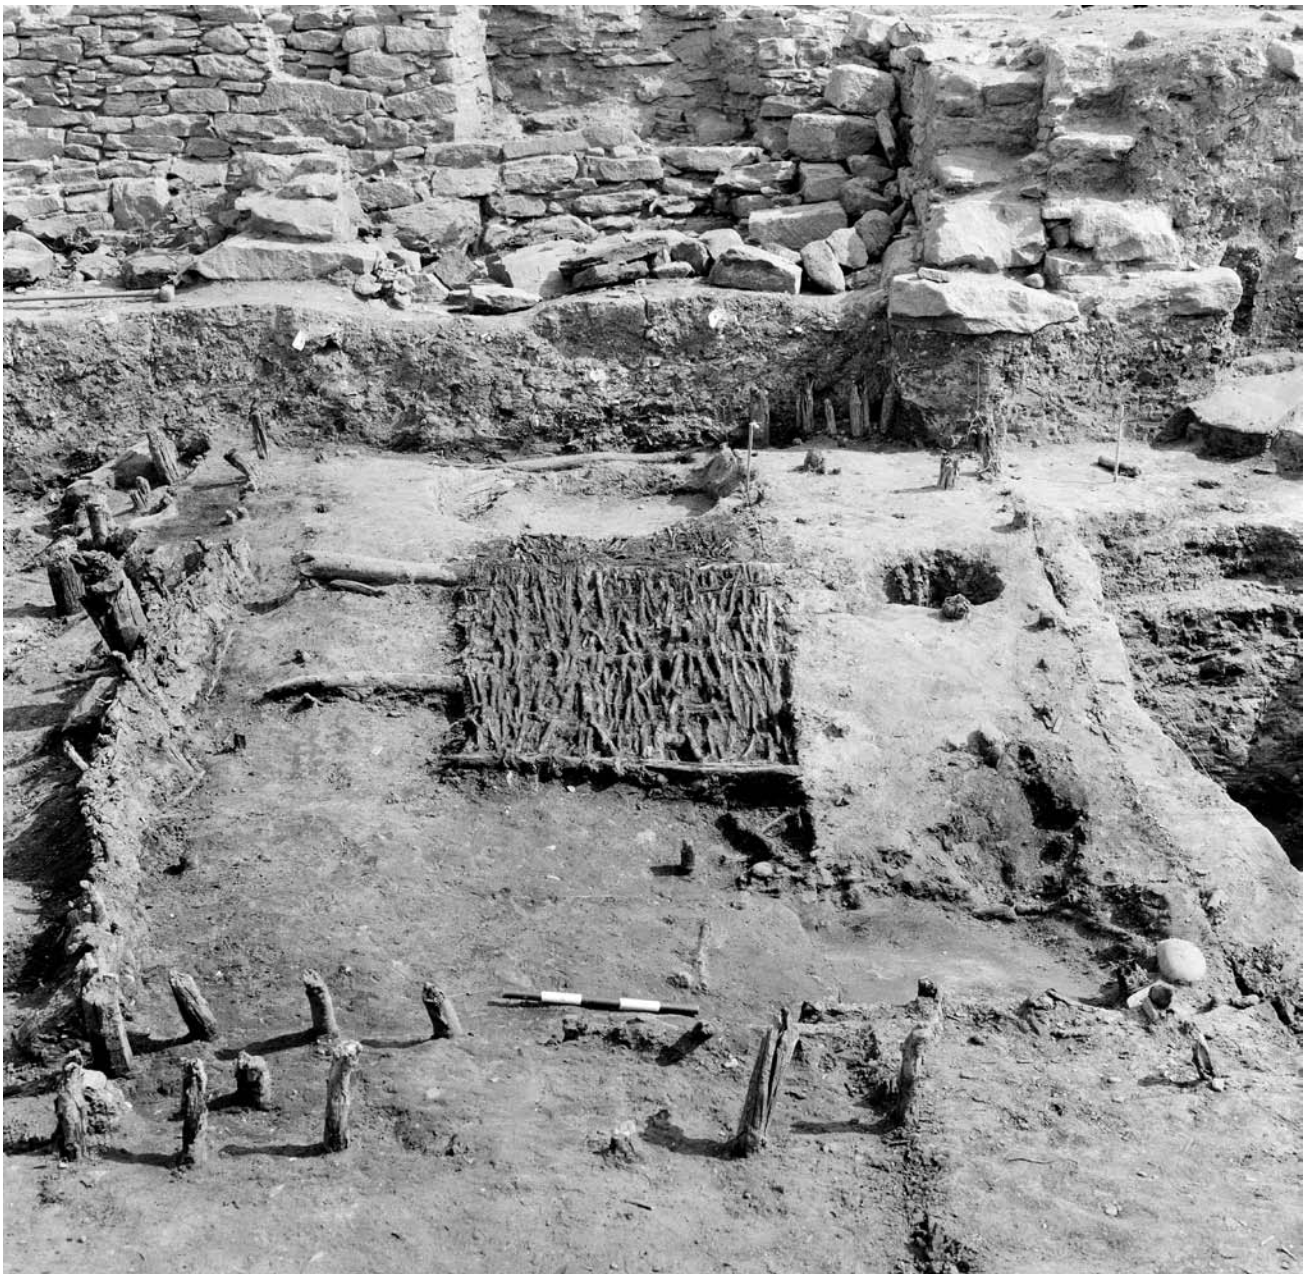
*Illus 63 South Sector: N end of Building 2, with hurdle MW2499, looking east.*  
(© Courtesy of RCAHMS. Licensor [www.rcahms.gov.uk](http://www.rcahms.gov.uk))

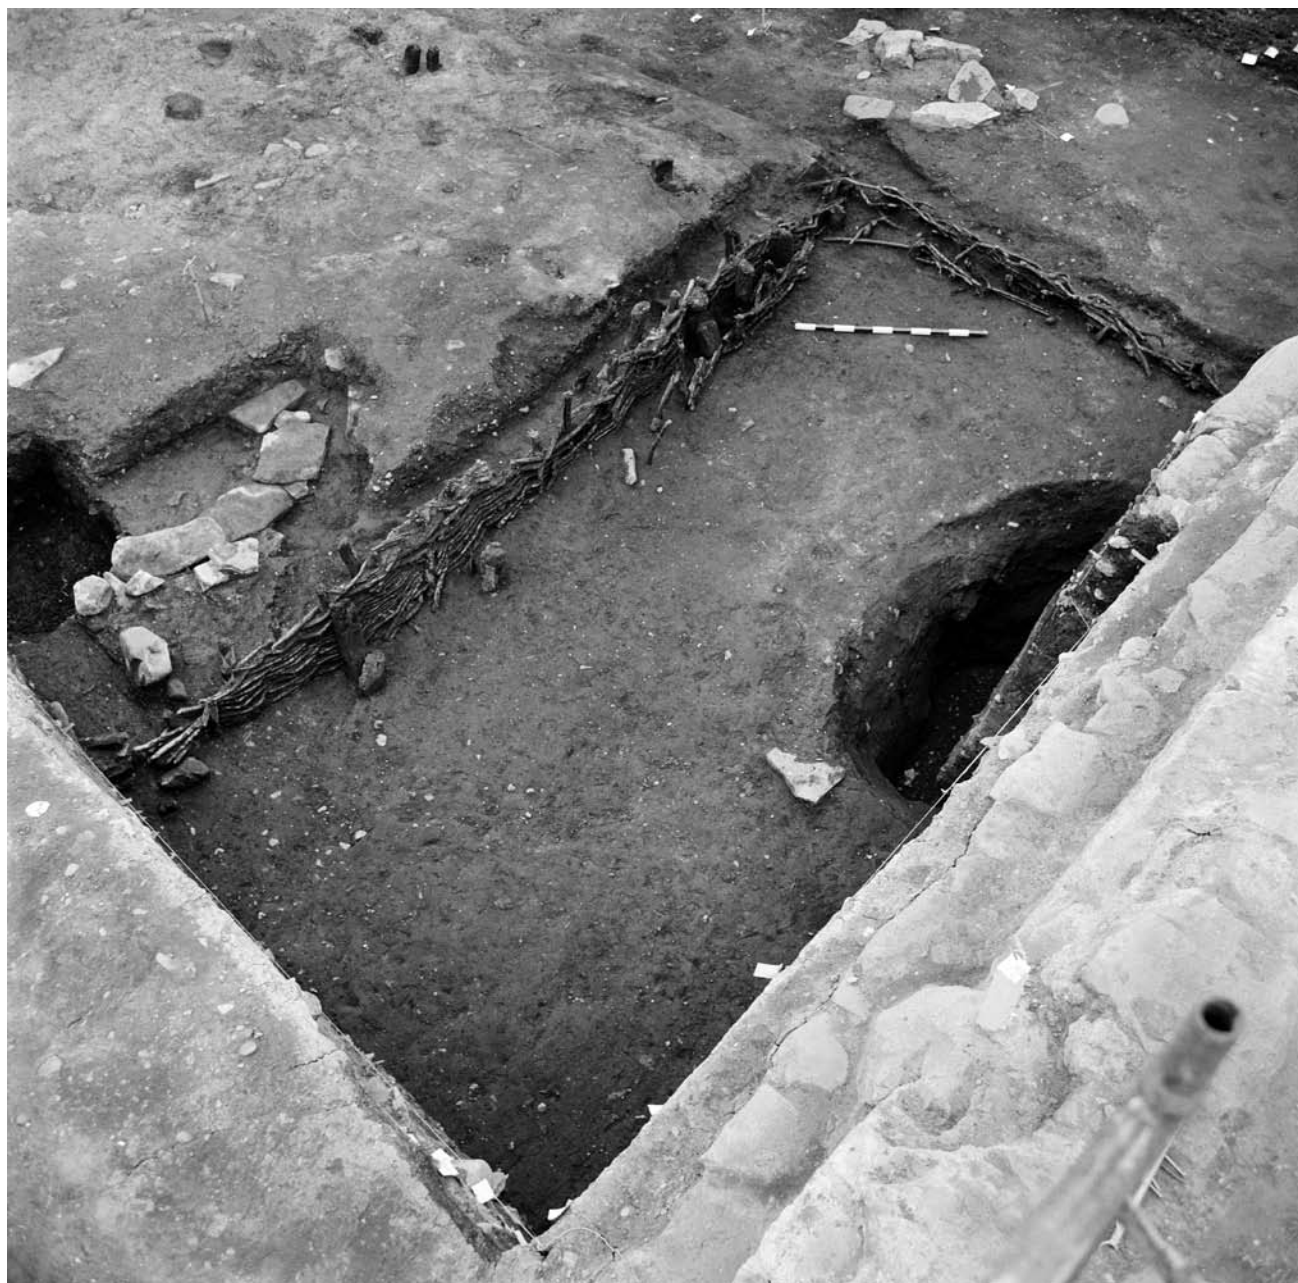
**Illus 65** *South Sector: Building 11, looking south-west.* (© Courtesy of RCAHMS. Licensor [www.rcahms.gov.uk](http://www.rcahms.gov.uk))

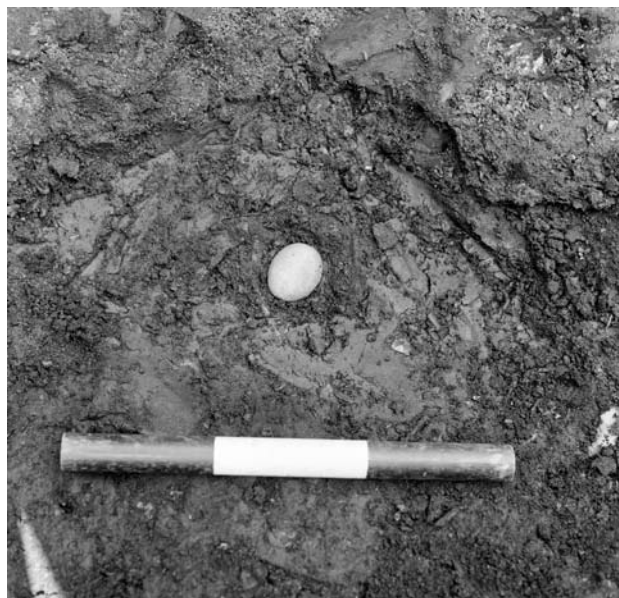
*Illus 67 South Sector: the second egg found in the excavation, in situ in Pit 2566.*

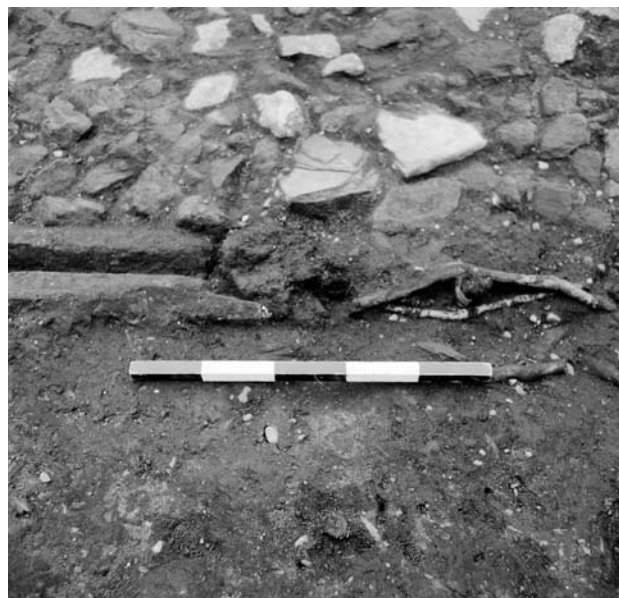
**Illus 68** *South Sector: post PP7281 between sill-beam MW7277 and wattle fence WW7282 in Building 18 (Phase 2), looking west. (© Courtesy of RCAHMS. Licensor [www.rcahms.gov.uk](http://www.rcahms.gov.uk))*

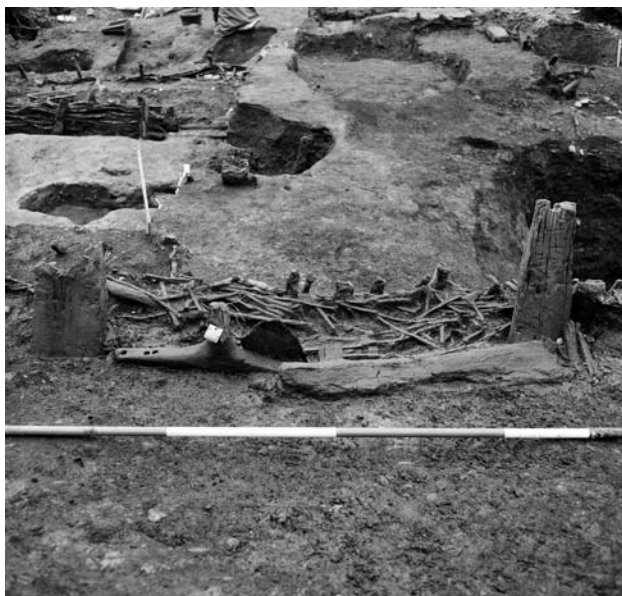
**Illus 69** *South Sector: timbers and posts along E wall of Building 18 (Phase 2), including oak claw thole MW6155 (The wood: Wood Cat No 254). (© Courtesy of RCAHMS. Licensor [www.rcahms.gov.uk](http://www.rcahms.gov.uk))*

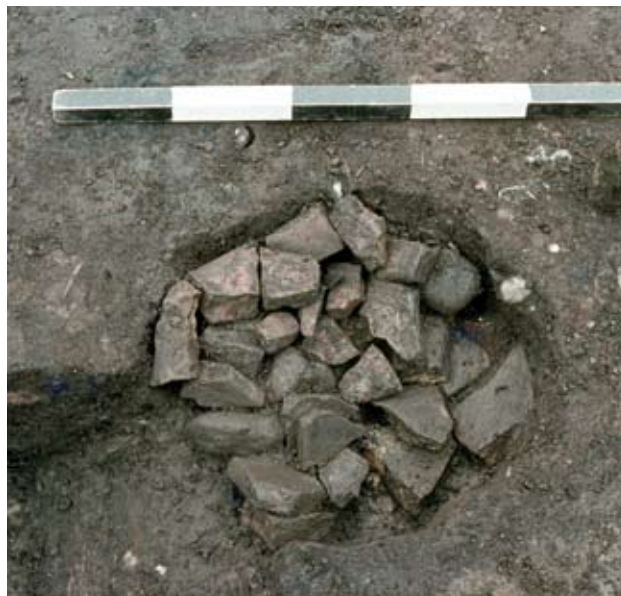
**Illus 70** *South Sector: pit MF7305 filled with tile fragments in Building 18 (Phase 2a). (© Courtesy of RCAHMS. Licensor [www.rcahms.gov.uk](http://www.rcahms.gov.uk))*

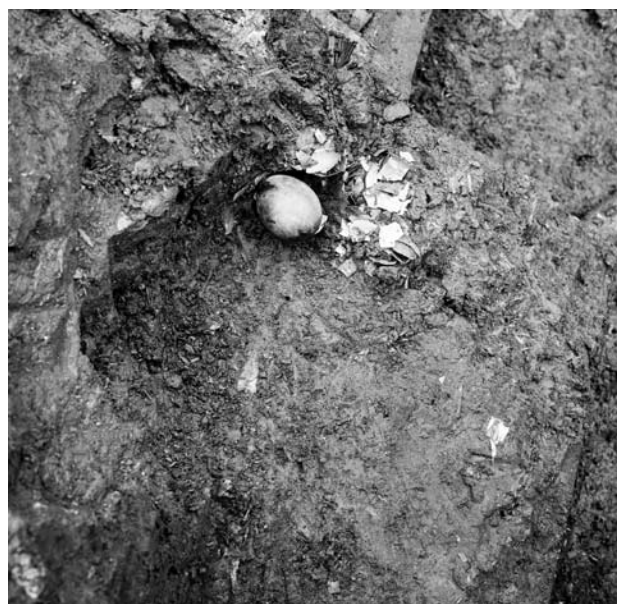
**Illus 71** South Sector: the third egg found in the excavation, in situ in Pit 7314. (© Courtesy of RCAHMS. Licensor [www.rcahms.gov.uk](http://www.rcahms.gov.uk))

Attached to the E end of the N wall of Building 18 (Phase 2) was a latrine, comprising a cesspit (Pit 7314) enclosed by a fence on its W side. The latrine was accessed from the north room/hall of the building through a doorway (door post PP7315, door sill MW 7318). The pit, 0.67m deep, was lined with dark brown clay, in which were embedded straw and plant remains, and filled with yellowish-green dung and reddish-brown clayey loam. It was in this pit that the third complete egg of the excavation was found (Illus 71), although unfortunately it was subsequently broken. Several timbers, some with rivets, were recovered from the pit (The wood: Wood Cat Nos 271–8 and 280), including two boat timbers (Wood Cat Nos 271 and 272); a bucket stave (Wood Cat No 279) and a bowl stave (Wood Cat No 282) were also recovered from the fills. Towards the end of B18 (Phase 2), the latrine went out of use and the area N of the building was replaced by a yard or midden of reddish-brown clayey dungy loam (C7268).

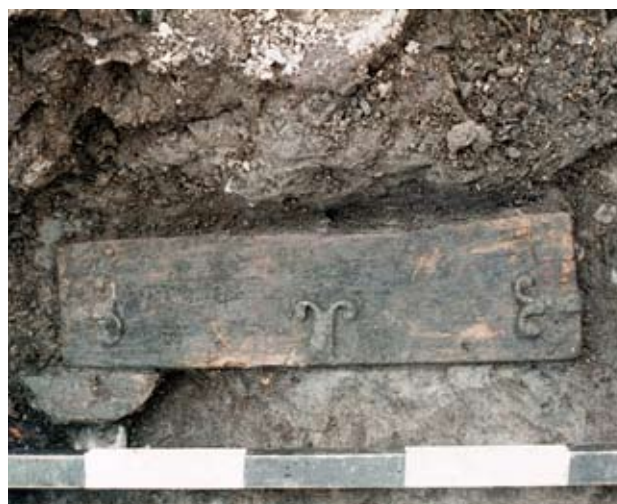
**Illus 72** South Sector: box lid with iron clasps (The wood: Wood Cat No 294) in situ in Building 18 (Phase 2b). (© Courtesy of RCAHMS. Licensor [www.rcahms.gov.uk](http://www.rcahms.gov.uk))

bone Cat No 29). Domestic finds include a candlestick (The metalwork: Metal Cat No 627), a copper alloy vessel (Metal Cat No 646), a hasp (Metal Cat No 650), a hinge pivot (Metal Cat No 651), a box lid with iron straps (The wood: Wood Cat No 294; Illus 72), four bowl staves (Wood Cat Nos 257 and 260–262) and two bucket staves (one splayed) (Wood Cat Nos 258 and 268). Military items are perhaps more surprising finds from an apparent burgess's house: an arrowhead, a spearhead, a gilded spur, chain mail and a lancehead (The metalwork: Metal Cat Nos 557, 619, 703, 708 and 724). The gilded spur 'indicates an owner of wealth and rank who was probably a knight' and probably dates from the late 13th century (The metalwork: Spurs report).

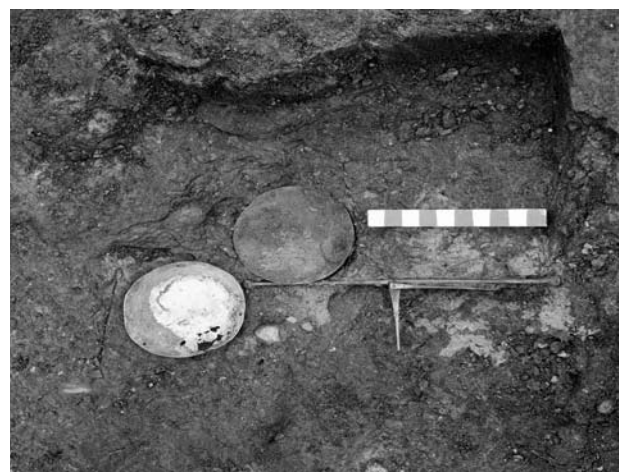
**Illus 74** South Sector: scales (The metal: Metal Cat No 1014) *in situ* in Midden 9b(b). (© Courtesy of RCAHMS. Licensor [www.rcahms.gov.uk](http://www.rcahms.gov.uk))
