## 3 The excavation: the South Sector

David R Perry

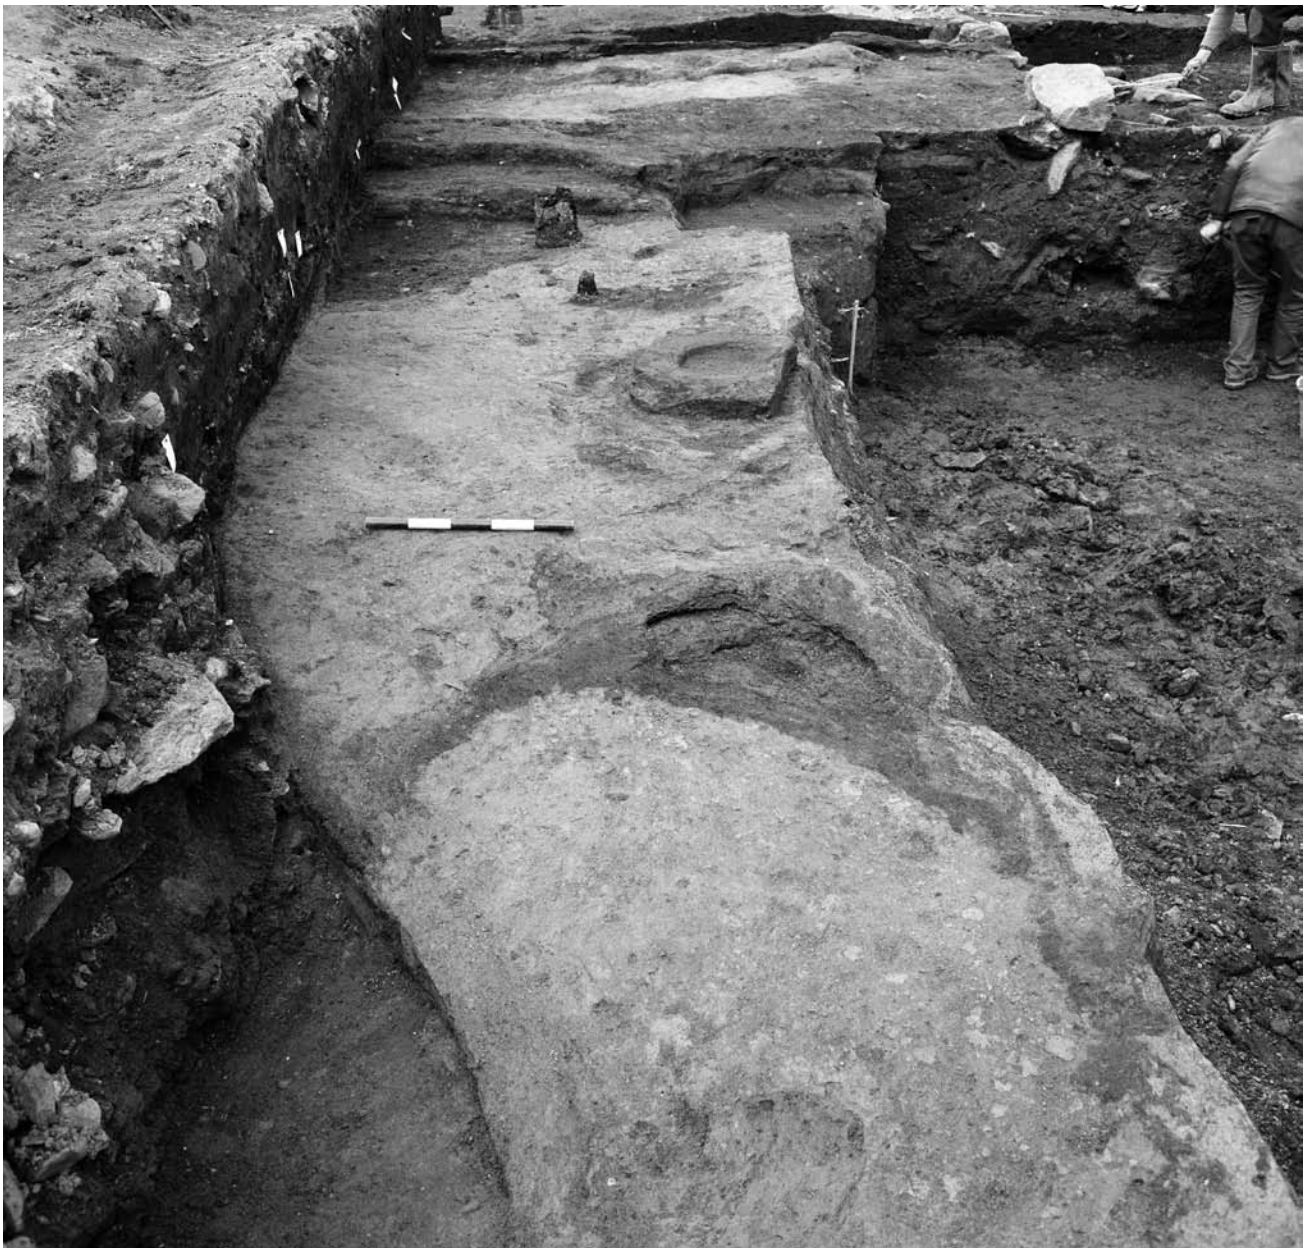
**Illus 76** *South Sector: south end of Building 1(a), looking north.*  
(© Courtesy of RCAHMS. Licensor [www.rcahms.gov.uk](http://www.rcahms.gov.uk))

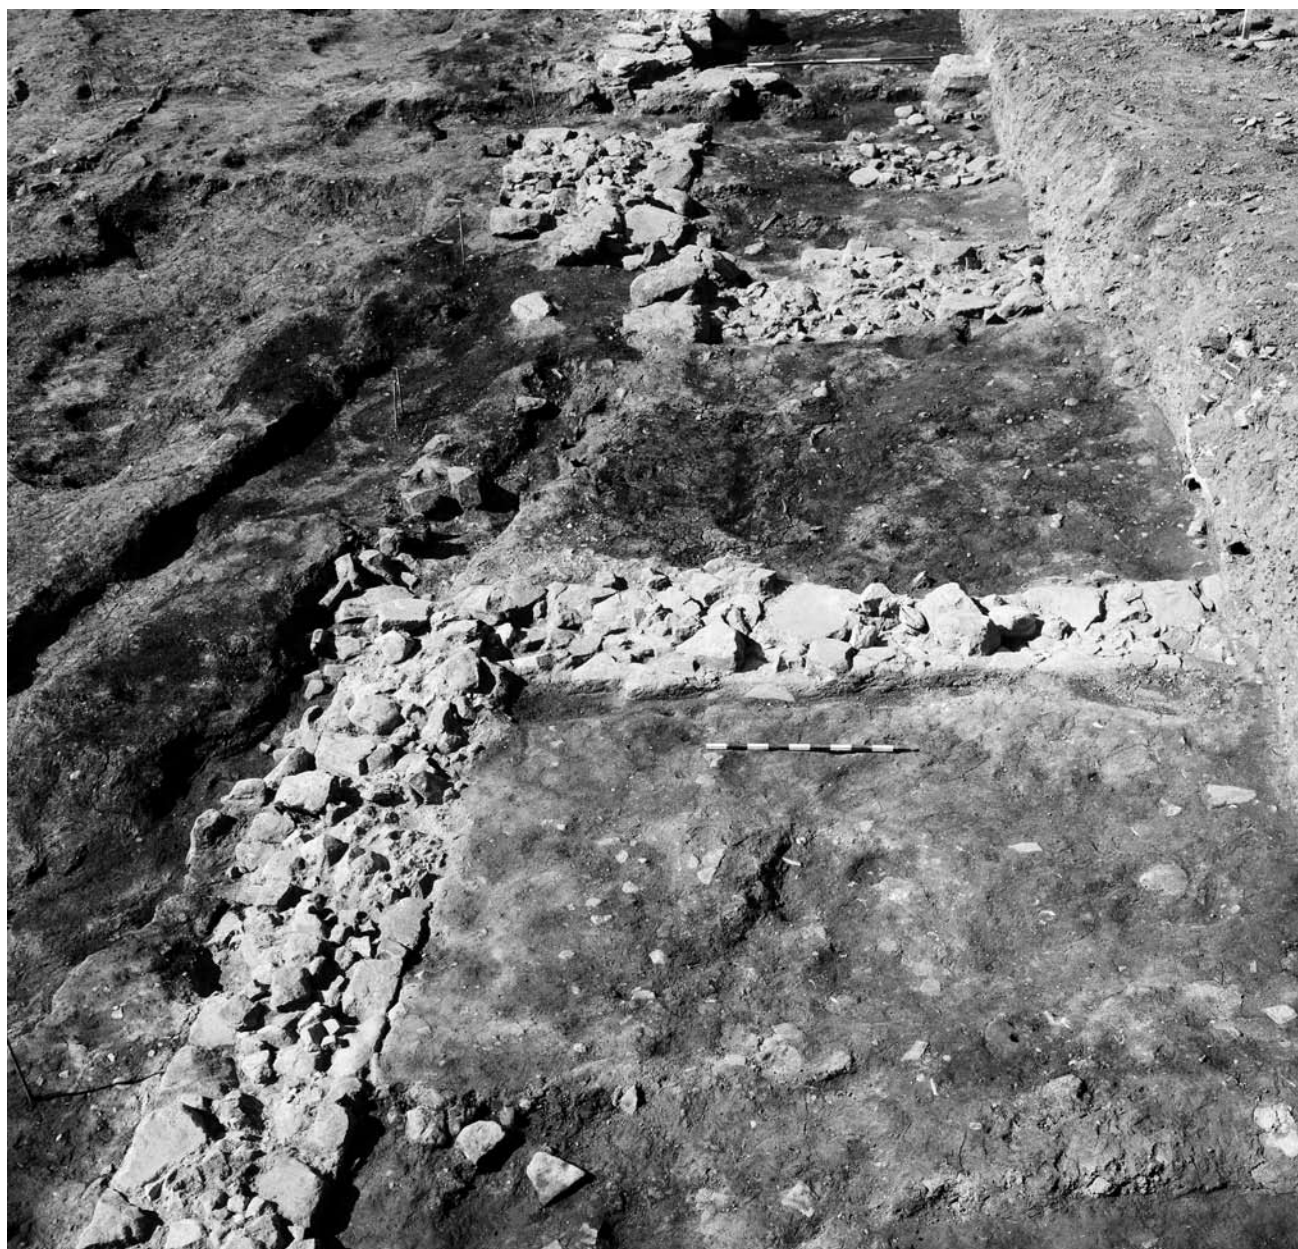
**Illus 77** *South Sector: Buildings 50 (foreground) and 51 (background), looking north.*  
(© Courtesy of RCAHMS. Licensor [www.rcahms.gov.uk](http://www.rcahms.gov.uk))

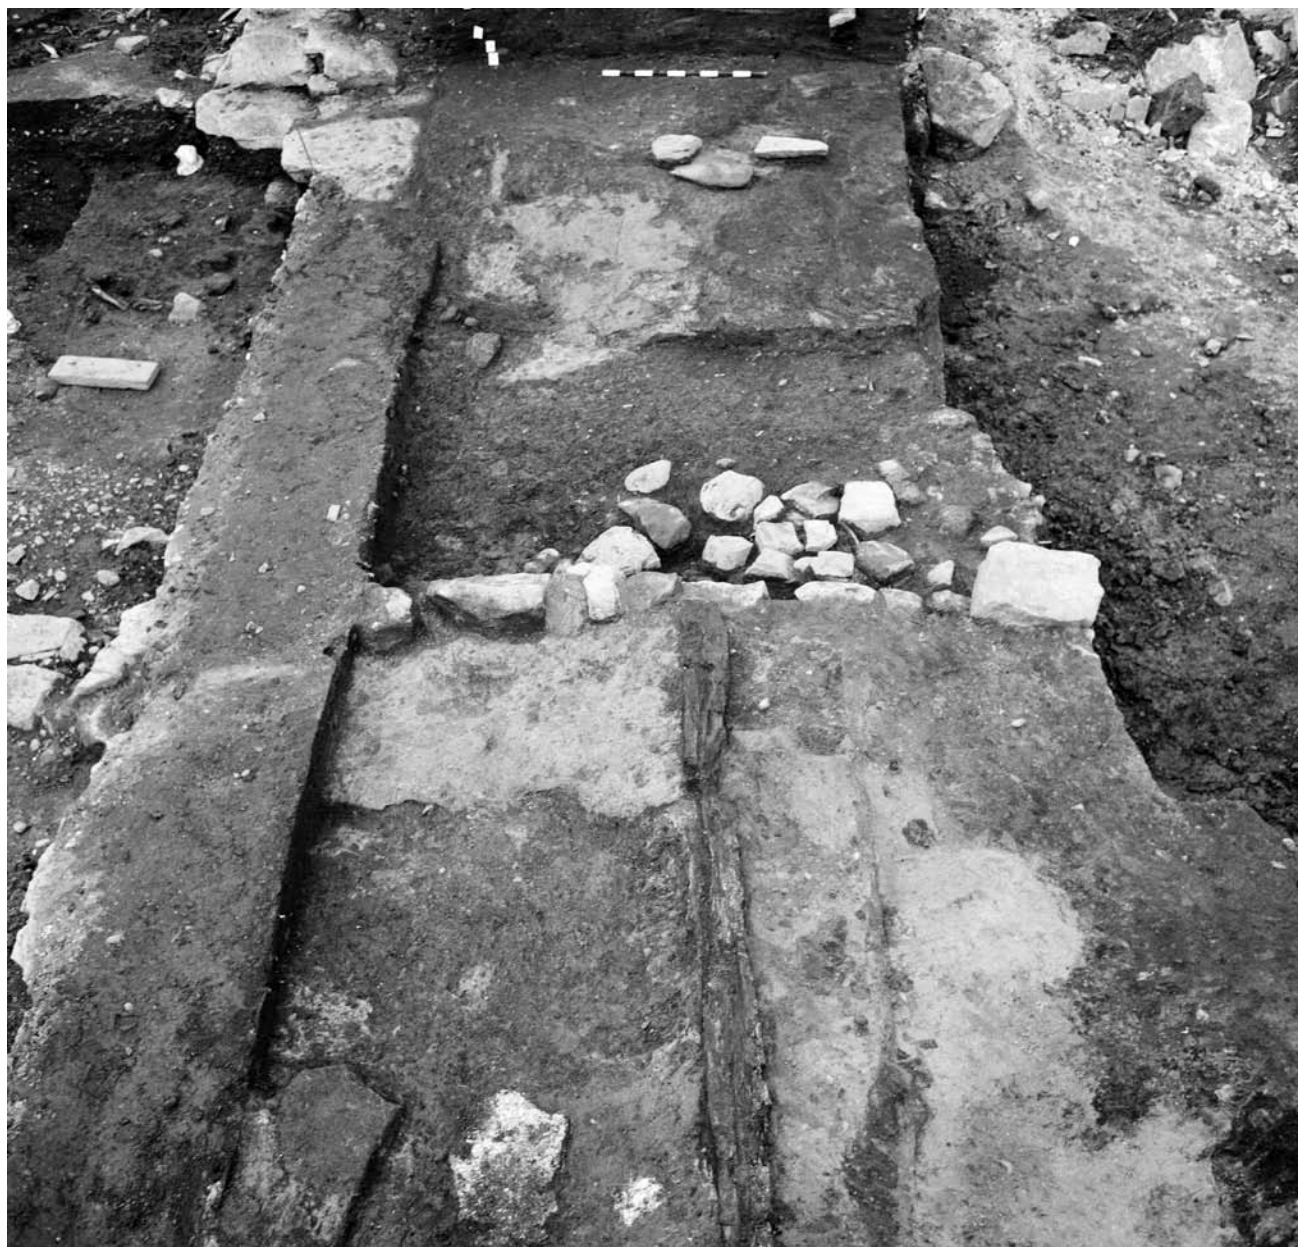
**Illus 79** *South Sector: Building 1(b): sill-beam MW2752, looking east.*  
(© Courtesy of RCAHMS. Licensor [www.rcahms.gov.uk](http://www.rcahms.gov.uk))

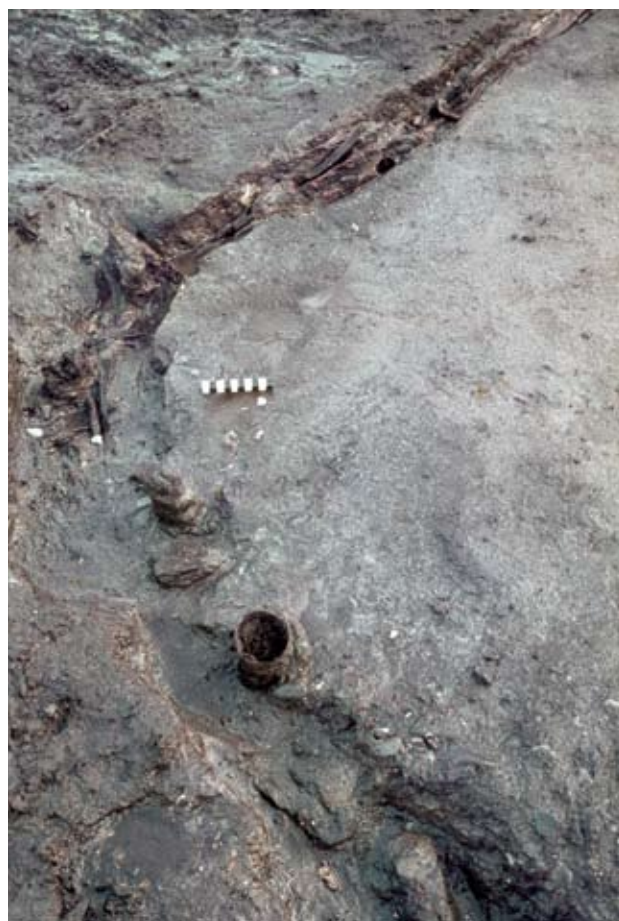
**Illus 80** *South Sector: north-west corner of Building 34, looking north-east (scale in centimetres). (© Courtesy of RCAHMS. Licensor [www.rcahms.gov.uk](http://www.rcahms.gov.uk))*

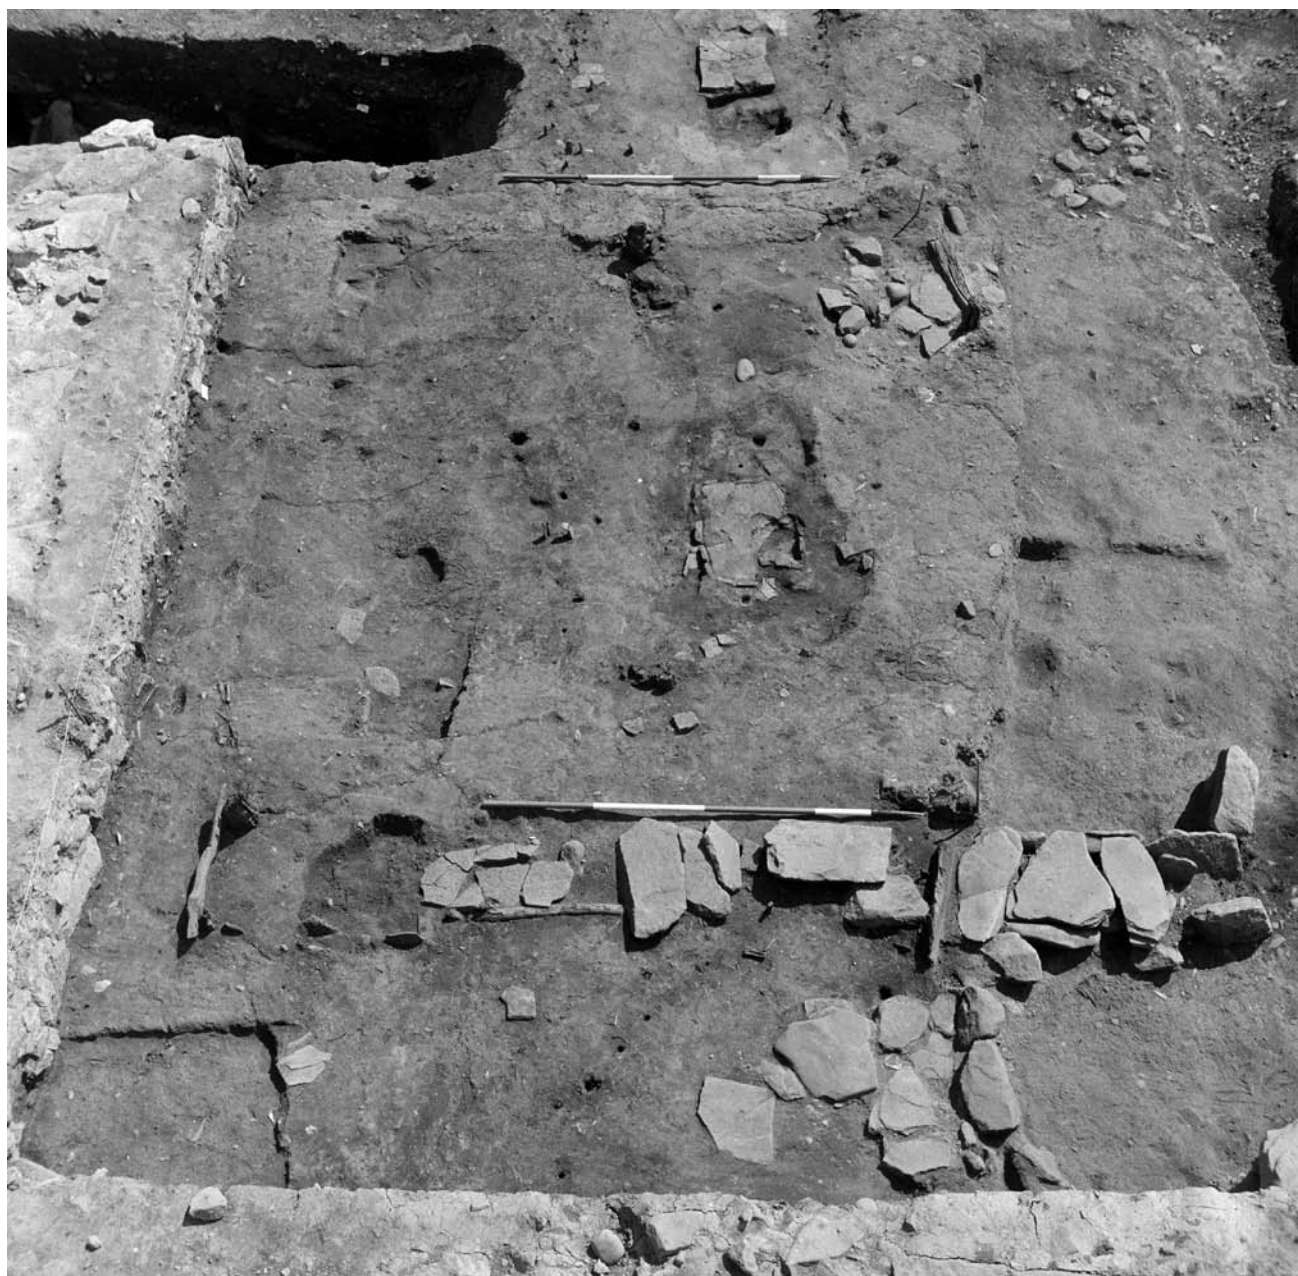
**Illus 83** *South Sector: Building 53 (Phase 1) with drain D7080 in foreground, looking south.*  
(© Courtesy of RCAHMS. Licensor [www.rcahms.gov.uk](http://www.rcahms.gov.uk))

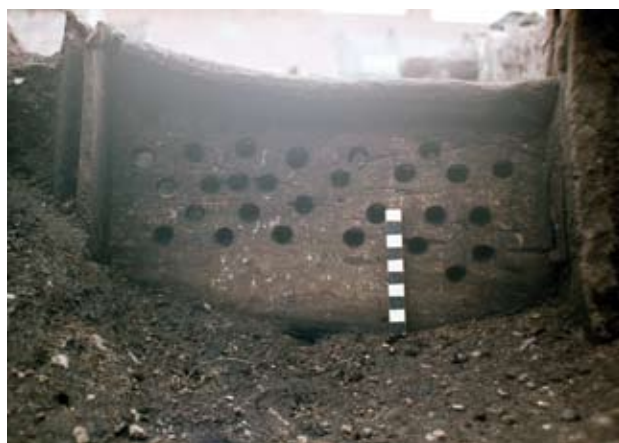
**Illus 84** South Sector: sluice MW7149 in situ in Building 53 (Phase 1), looking west (scale in centimetres). (© Courtesy of RCAHMS. Licensor [www.rcahms.gov.uk](http://www.rcahms.gov.uk))

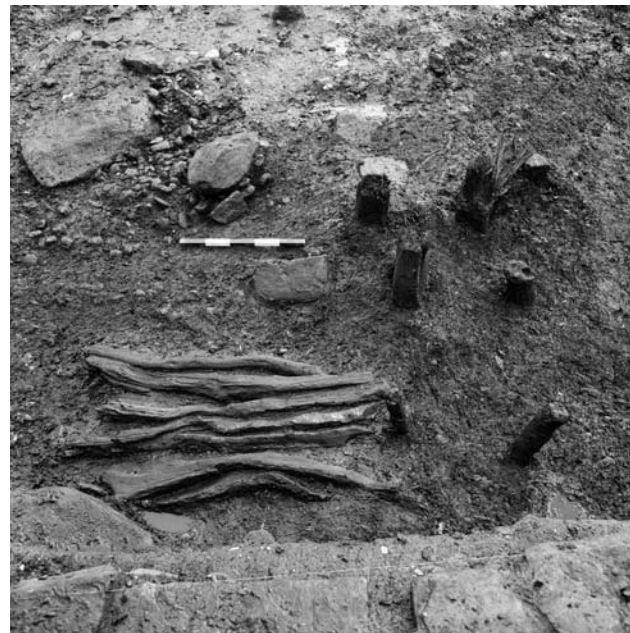
**Illus 90** South Sector: timbers MW2160, in Path 1a with post PP2143A–G to right, looking south. (© Courtesy of RCAHMS. Licensor [www.rcahms.gov.uk](http://www.rcahms.gov.uk))

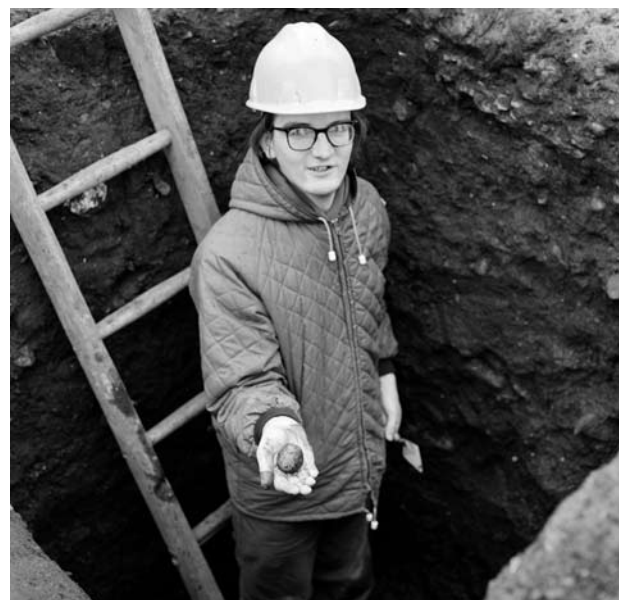
**Illus 93** South Sector: the first egg found in the excavation, in Pit 2111 in Midden 3e. (© Courtesy of RCAHMS. Licensor [www.rcahms.gov.uk](http://www.rcahms.gov.uk))

fills were completely different from the lowest fills: greenish-grey clayey loam (C2129), yellow and grey mixed clay and loam (C2116), reddish-brown peaty clay (C2115), greyish-brown clayey loam with patches of sand (C2114), reddish-brown clay (C2113) and soft greyish-brown clayey loam (C2112). The pit was clearly a cesspit in its primary phase, with the clay lining marking a change of use. The burning of the lining was presumably after its secondary use was ended, when it was infilled with various small lenses. It was from the cess fills that the first of the three eggs found during the excavation was recovered (see Environmental Report) (Illus 93). Also recovered from the

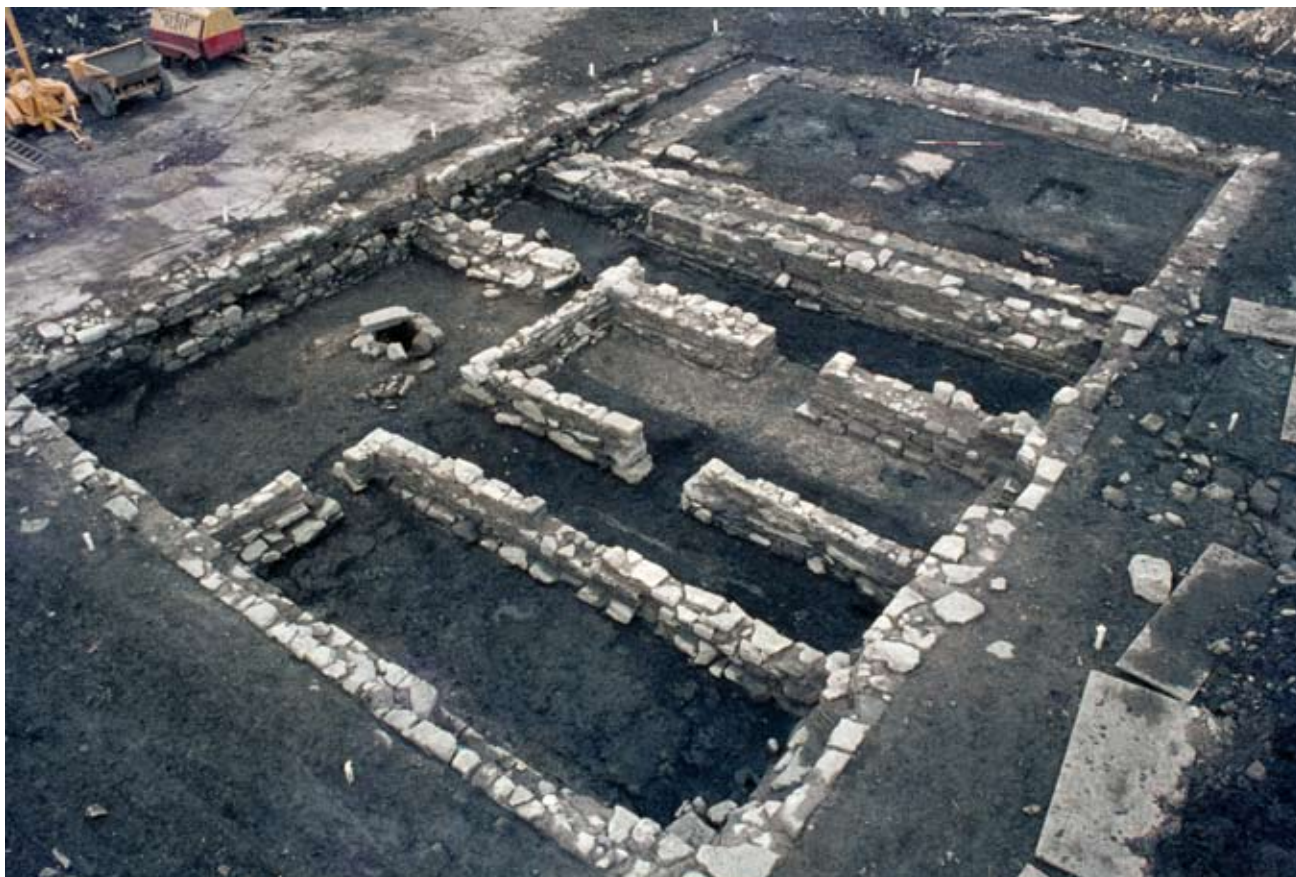
**Illus 96** *South Sector: remains of wall foundations of 'Old Parliament House'/Masonic Hall (Buildings G and GI), looking north-west. (© Courtesy of RCAHMS. Licensor [www.rcahms.gov.uk](http://www.rcahms.gov.uk))*

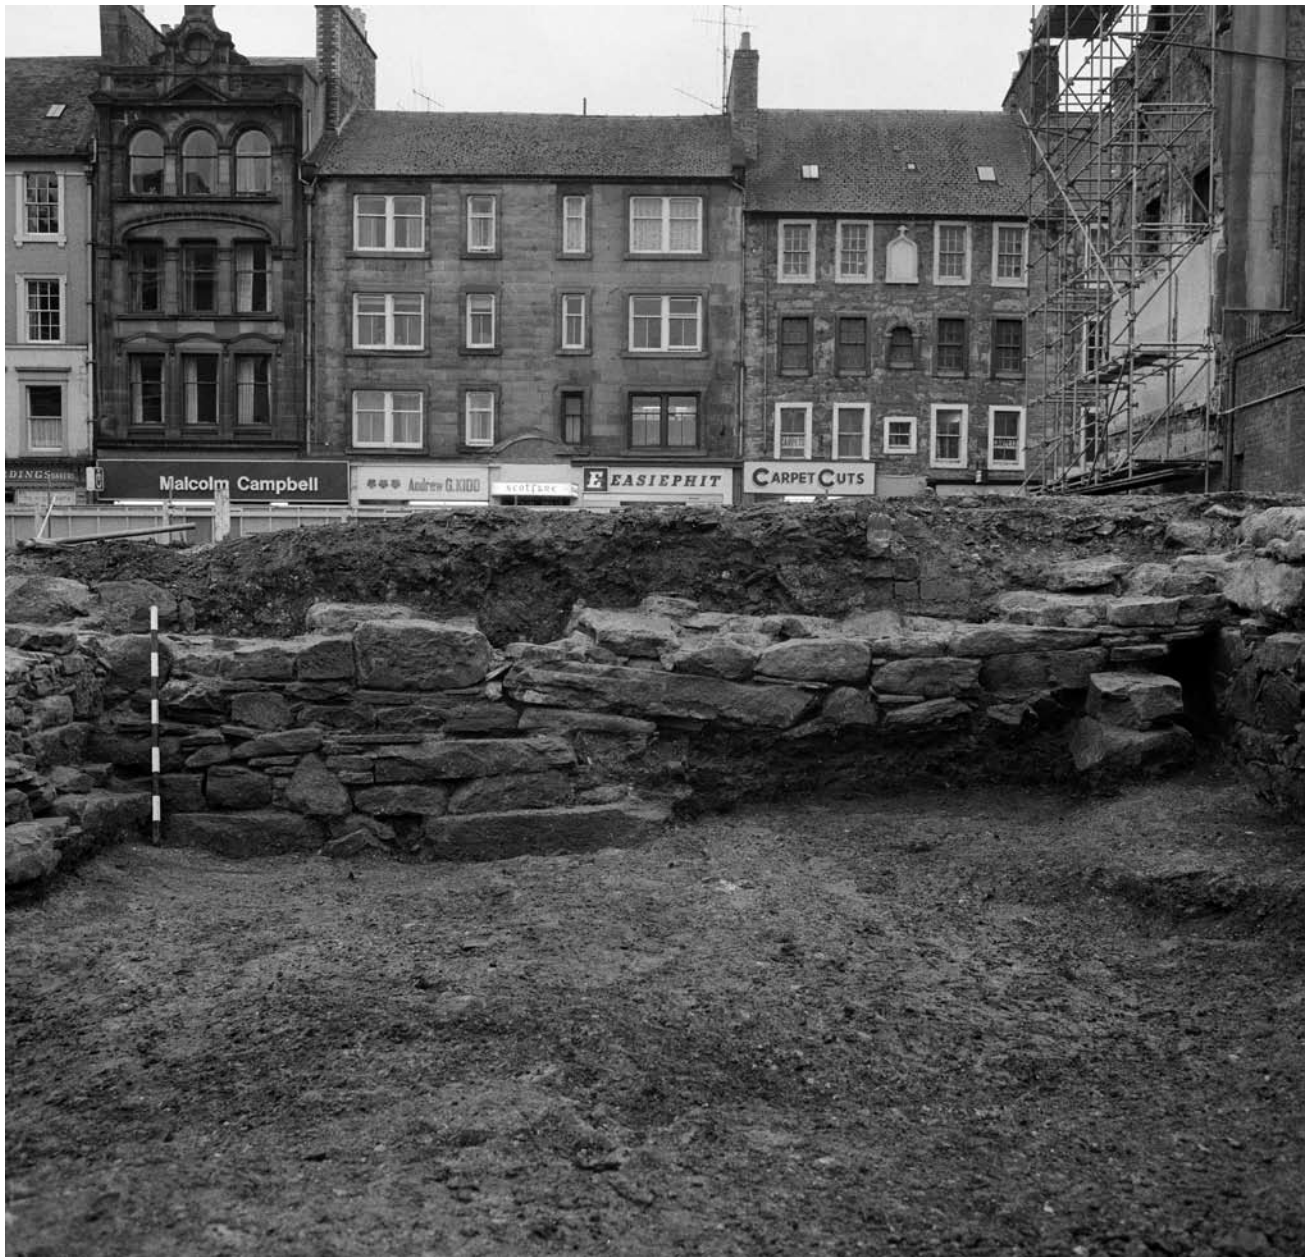
*Illus 97 South Sector: west end of south wall (Wall 2020) of 'Old Parliament House'/Masonic Hall (Building G), showing two phases of construction, looking south. (© Courtesy of RCAHMS. Licensor [www.rcahms.gov.uk](http://www.rcahms.gov.uk))*
